PROPERTY INSPECTION REPORT

Your Future address

Date of Inspection: 10/8/2019 Time: 3:15 PM

Age of Home: 1912 Size: 1800sf

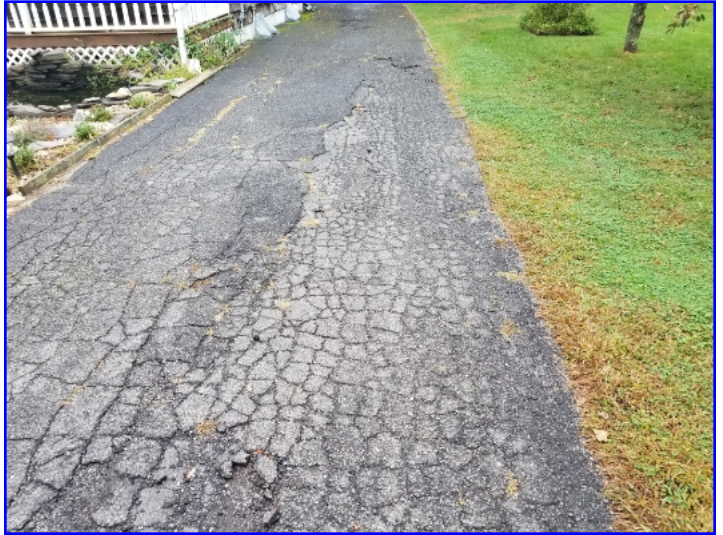
5. Driveway Condition

- The driveway was severely deteriorated and needed extensive work at the time of the inspection. The Inspector recommends that before the expiration of your Inspection Objection Deadline you consult with a qualified contractor to discuss options and costs for repair.

The driveway was severely deteriorated and needed extensive work at the time of the inspection. The Inspector recommends that before the expiration of your Inspection Objection Deadline you consult with a qualified contractor to discuss options and costs for repair.

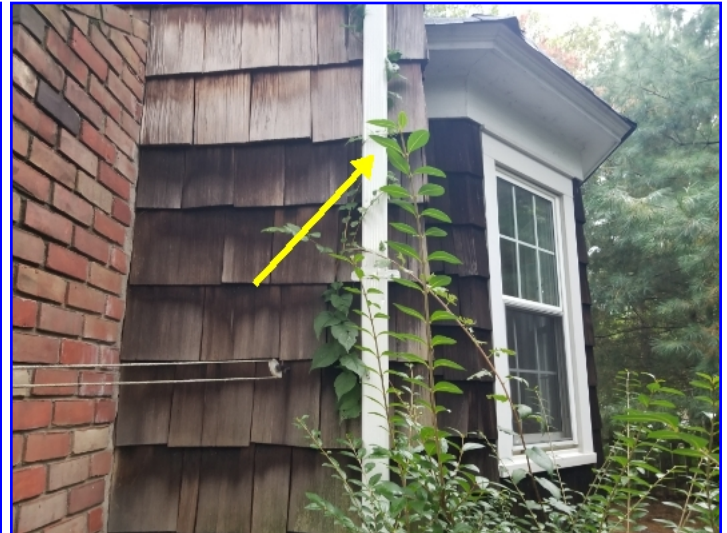
- Vines growing on the exterior walls may introduce insects, pests and/or accelerate deterioration of the exterior wall covering by retaining moisture. Over time, vine tendrils may damage wall covering materials.

Vines growing on the exterior walls may introduce insects, pests and/or accelerate deterioration of the exterior wall covering by retaining moisture. Over time, vine tendrils may damage wall covering materials.

Watering this vegetation will introduce moisture to the soil which may eventually reach the foundation. Moisture in soil supporting the foundation can affect the ability of the foundation to support the weight of the structure above and can cause damage from soil heaving or settling, depending on soil composition and other conditions. The Inspector recommends removal of the vegetation from exterior walls.

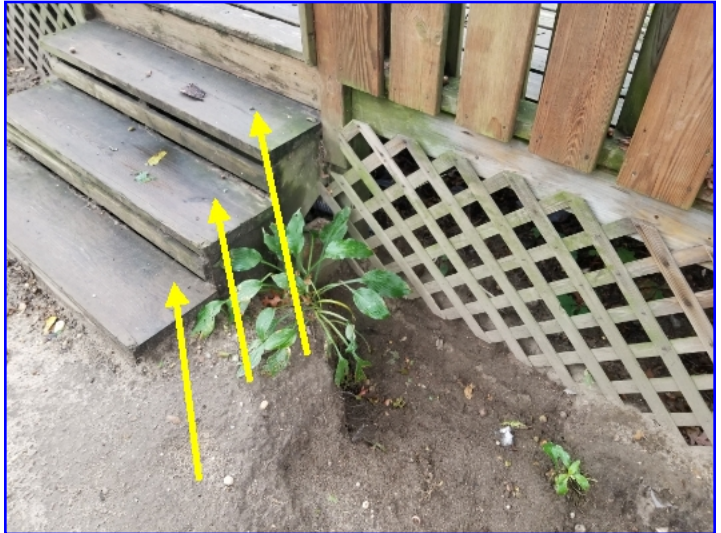
This deck staircase had no handrail. Safe building practices dictate that stairs with 4 or more risers should have a handrail. You should consult with a qualified contractor before the expiration of your Inspection Objection Deadline to discuss options and costs for handrail installation.

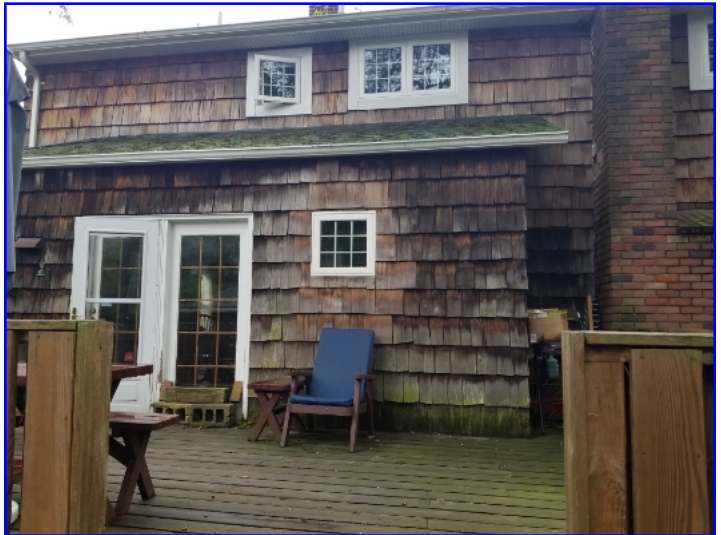
16. Siding defects

- Wood shingles covering exterior walls exhibited moderate deterioration commensurate with the age of the home. Some wood shingles covering exterior walls were split. Splitting is typically due to age and exposure to weather and an often-used rule of thumb calls for replacement when 30% or greater of shingles are split. The percentage of split shingles covering exterior walls appeared to be lower than 30% at the time of the inspection.
- The wood shingle exterior wall covering had some damaged shingles visible at the time of the inspection. The Inspector recommends replacement of damaged shingles to help prevent damage from moisture intrusion to the home materials, the exterior wall structure and to prevent development of microbial growth such as mold. All work should be performed by a qualified contractor. Fill in all holes with appropriate materials.

The wood shingle exterior wall covering had some damaged shingles visible at the time of the inspection. The Inspector recommends replacement of damaged shingles to help prevent damage from moisture intrusion to the home materials, the exterior wall structure and to prevent development of microbial growth such as mold. All work should be performed by a qualified contractor. Fill in all holes with appropriate materials.

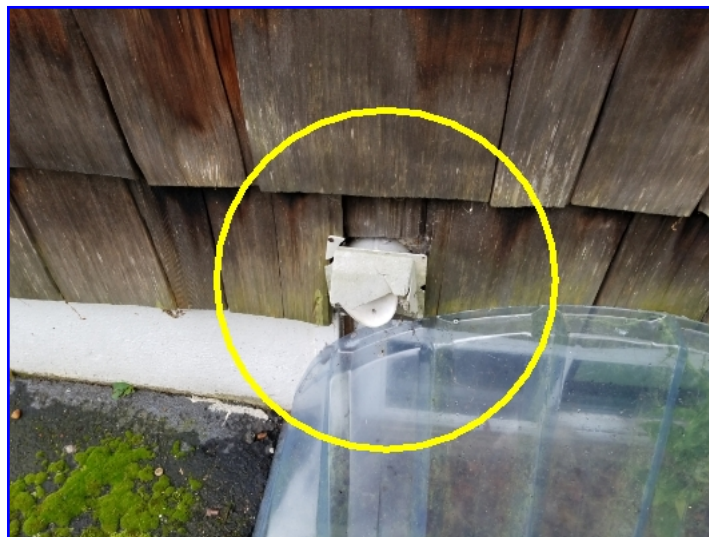
Dryer vent cover is damaged.

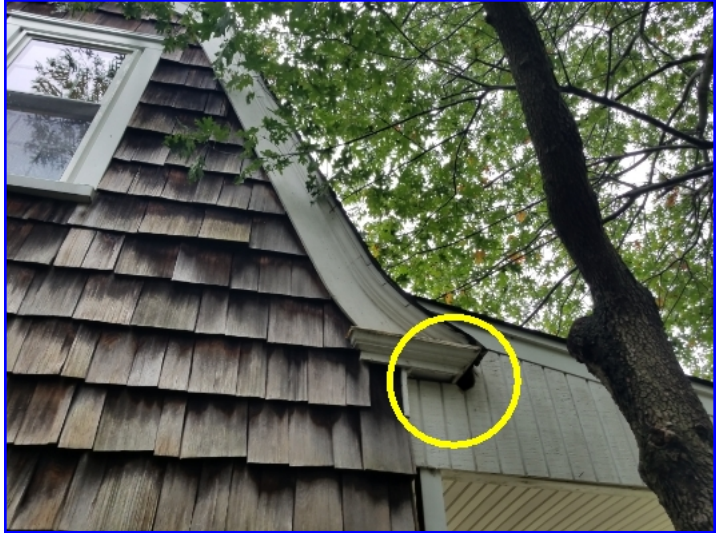
Home fascia in front of home was damaged and should be repaired. The Inspector recommends repair by a qualified contractor.

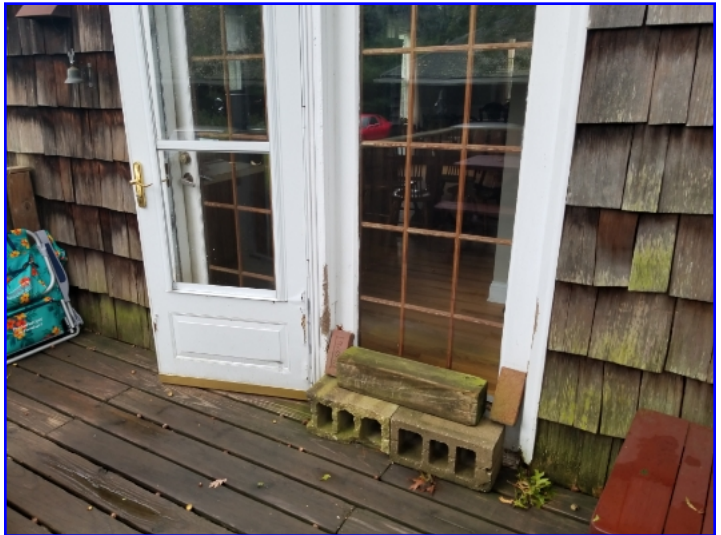
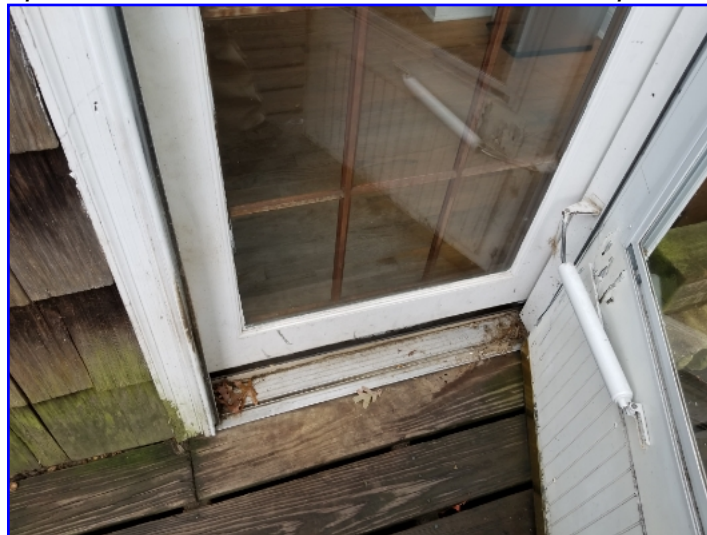
A door to the exterior back deck was severely damaged and/or deteriorated. The Inspector recommends that before the expiration of your Inspection Objection Deadline, you consult with a qualified contractor to discuss options and costs for repair or replacement.

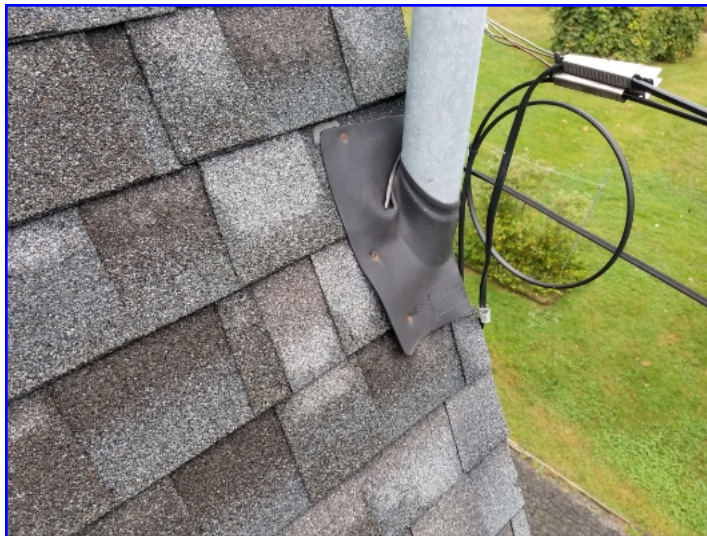
The point at which the electrical mast penetrated the roof-covering material did not have proper flashing installed. The inspector recommends correction by a qualified roofing contractor.

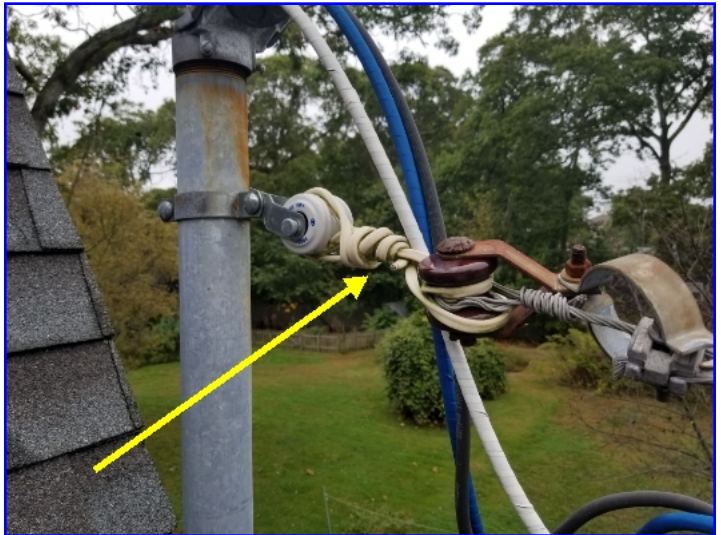
The overhead service-drop conductors were routed near tree branches. Although this did not appear to be a problem at the time of the inspection, as tree branches grow they may begin to contact and abrade the service conductors during windy periods. You should monitor this area in the future and arrange to have tree branches cut back as necessary.

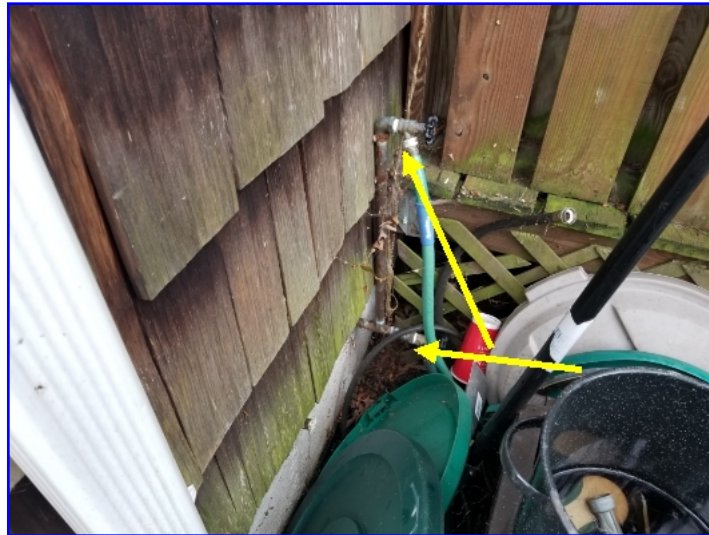
An exterior faucet at the rear of the house was inoperable. The Inspector recommends repair by a qualified plumbing contractor.

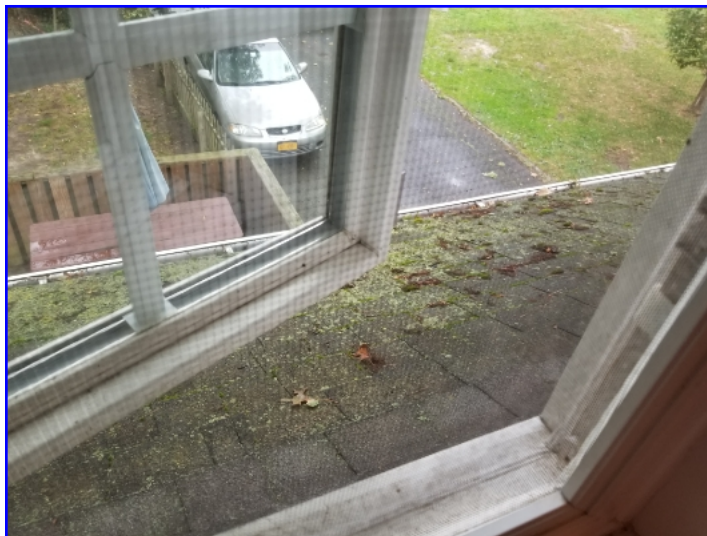
Page 22 Item: 4	General Condition	<ul style="list-style-type: none"> • Moss was growing on the rear roof. As a result, shingles can lift or be damaged. Leaks can result and/or the roof surface can fail prematurely. Efforts should be made to kill the moss during its growing season (wet months). Typically, zinc or phosphate-based chemicals are used for this and must be applied periodically. Cut back trees overhanging house.
Page 23 Item: 6	Gutter	<ul style="list-style-type: none"> • Debris visible in the gutters at the time of the inspection should be removed to encourage proper drainage.

Moss was growing on the rear roof. As a result, shingles can lift or be damaged. Leaks can result and/or the roof surface can fail prematurely. Efforts should be made to kill the moss during its growing season (wet months). Typically, zinc or phosphate-based chemicals are used for this and must be applied periodically. Cut back trees overhanging house.

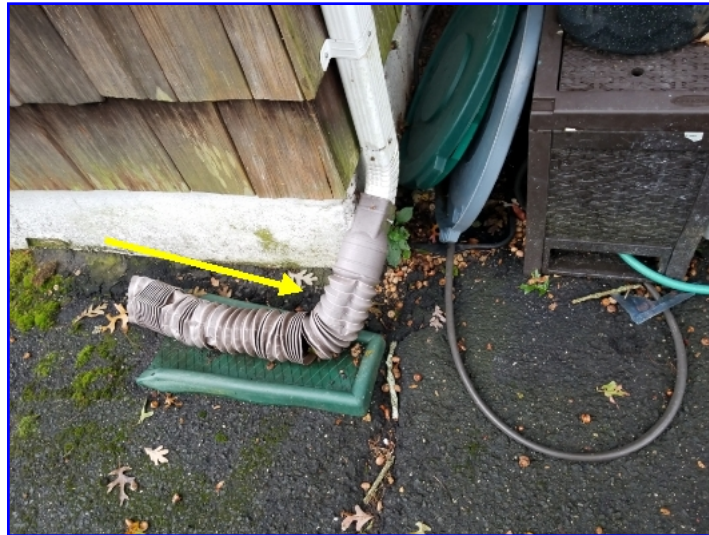
One or more downspouts discharged roof drainage next to the foundation. This condition can effect the ability of the soil to support the weight of the structure above and can cause damage related to soil/foundation movement. The Inspector recommends the installation of downspout extensions to discharge roof drainage a minimum of 6 feet from the foundation.

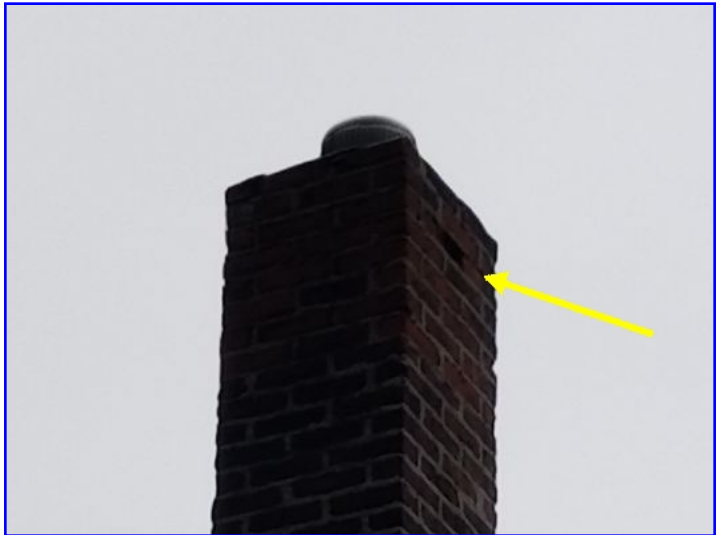
The chimney had bricks missing at the time of the inspection. This condition indicated a failure of the bond between mortar and brick and may cause other bricks to fall if not corrected. Falling bricks may cause injury or death. The Inspector recommends that before the expiration of your Inspection Objection Deadline you consult with a qualified contractor to discuss options and costs for repair.

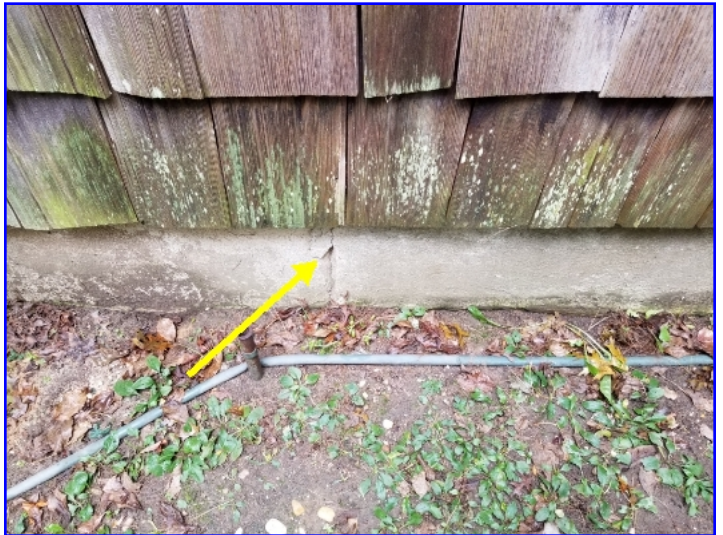
All cracks in exterior block and parge coat should be filled and sealed.

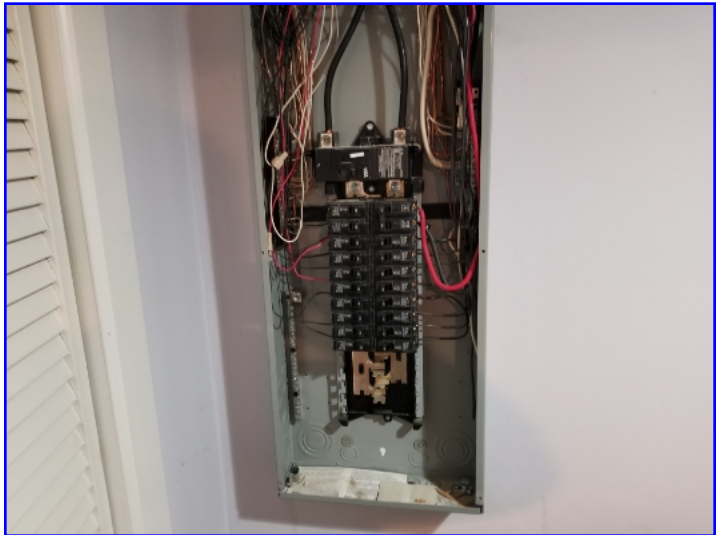
Ground and neutral wires in the service panel terminated on the same bus bar. This condition is improper and should be corrected by a qualified electrical contractor.

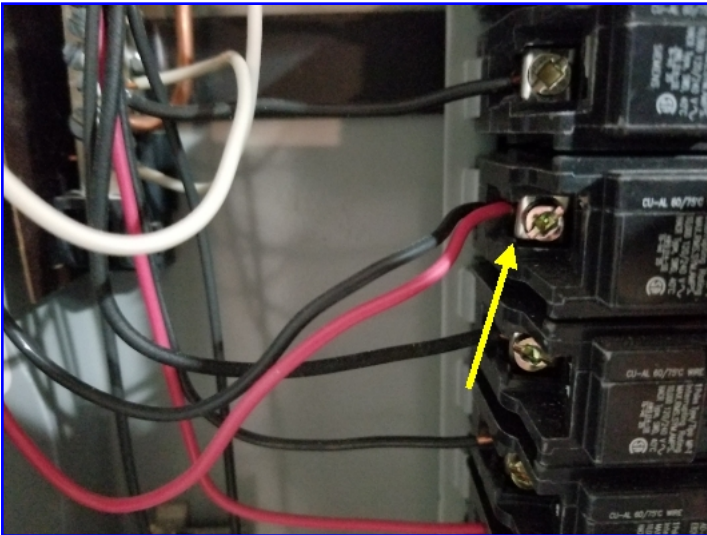
Page 28 Item: 9	Overcurrent Protection	<ul style="list-style-type: none"> In the service panel, two wires were connected to a breaker designed for only one wire. This is known as a "double-tap" and is a defective condition that should be corrected by a qualified electrical contractor.
-----------------	------------------------	---

In the service panel, two wires were connected to a breaker designed for only one wire. This is known as a "double-tap" and is a defective condition that should be corrected by a qualified electrical contractor.

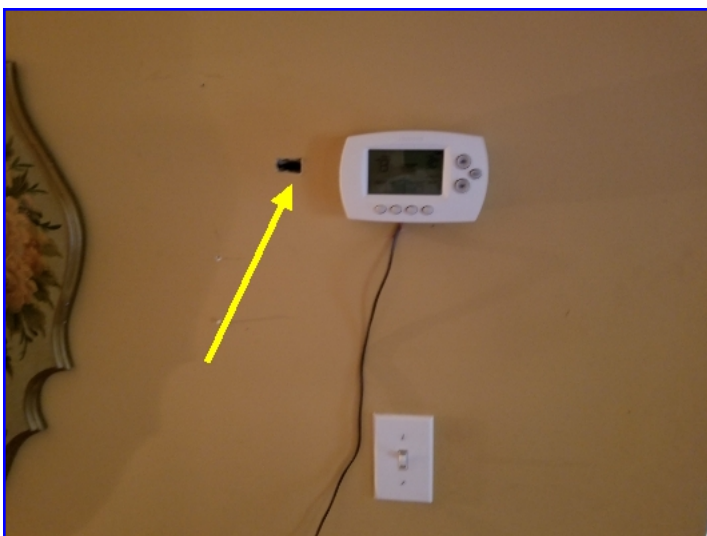
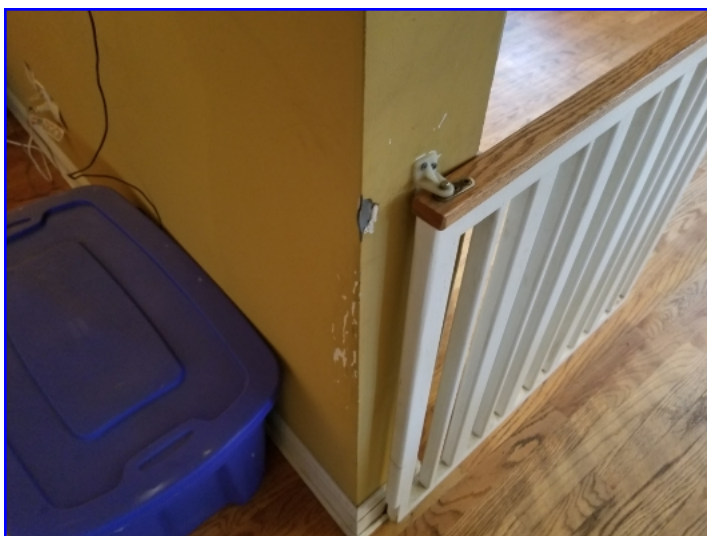
Interior walls in the home exhibited general minor damage or deterioration at the time of the inspection.

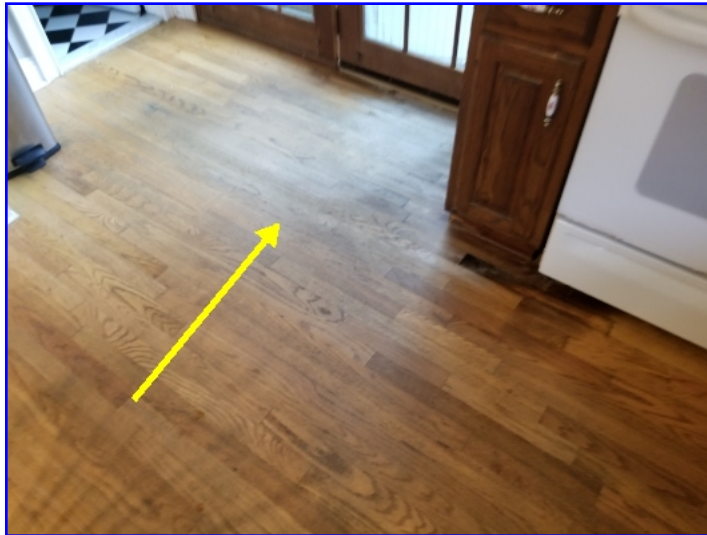
The wood flooring in the kitchen was cupped. Cupping occurs across the width of the individual pieces of flooring. The edges are high and the center is lower. It generally develops gradually.

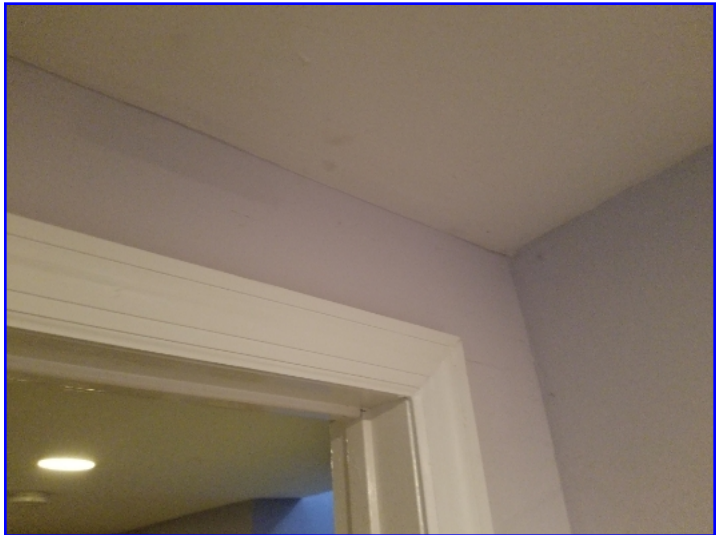
Stains on the ceiling in the basement visible at the time of the inspection appeared to be the result of moisture intrusion from plumbing fixtures or pipes located in or at the floor above. The moisture meter showed no elevated levels of moisture present in the affected areas at the time of the inspection, indicating that the source of moisture may have been corrected. You should ask the seller about this condition. Before the expiration of your Inspection Objection Deadline you may wish to consult with a qualified contractor to discuss options and costs for re-painting the ceiling.

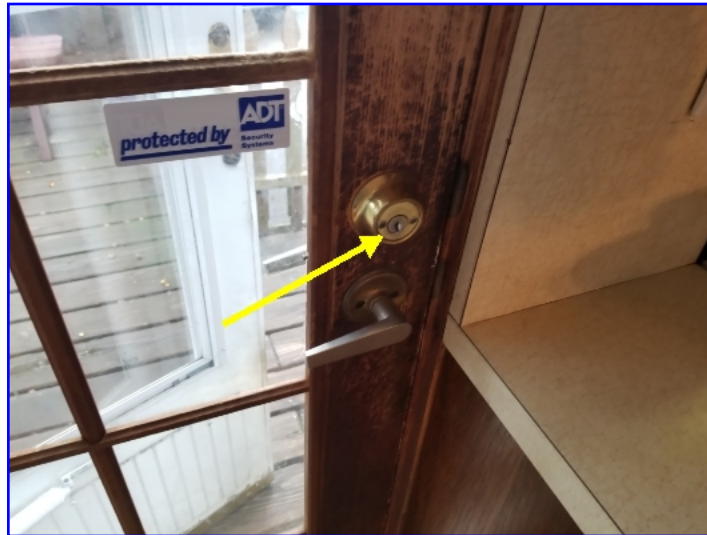
A door to the exterior in the rear of home had a deadbolt which required a key for operation from the inside. This condition is unsafe as it may slow or prevent exit during an emergency. Installation of these types of deadbolts is no longer allowed in new construction. The Inspector recommends that all deadbolts in the home that require a key for exit from the home interior be replaced with a deadbolt that operates from the inside with a lever. All work should be performed by a qualified contractor.

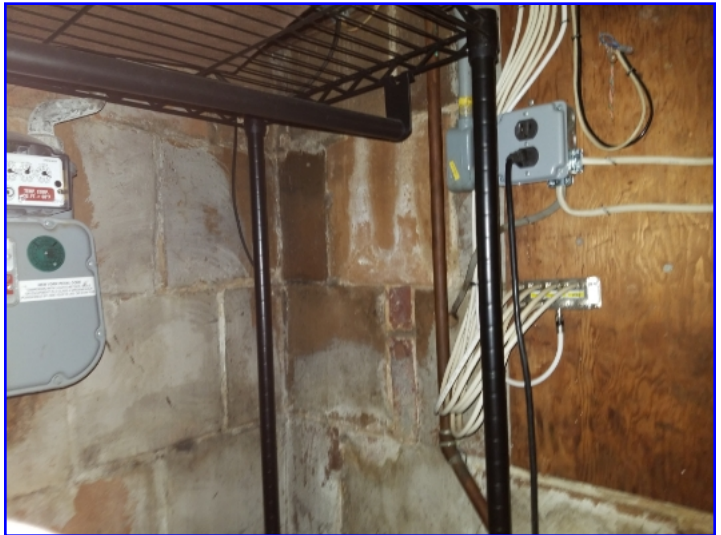
In the basement, moderate amounts of efflorescence was visible at some of the interior surfaces of the foundation walls. Efflorescence is a white, powdery residue left by moisture seeping through the foundation wall and its presence indicates high moisture levels in soil near the foundation. Excessively high moisture levels in soil supporting the foundation can cause various structural problems related to soil movement. The source of moisture should be identified and the condition corrected.

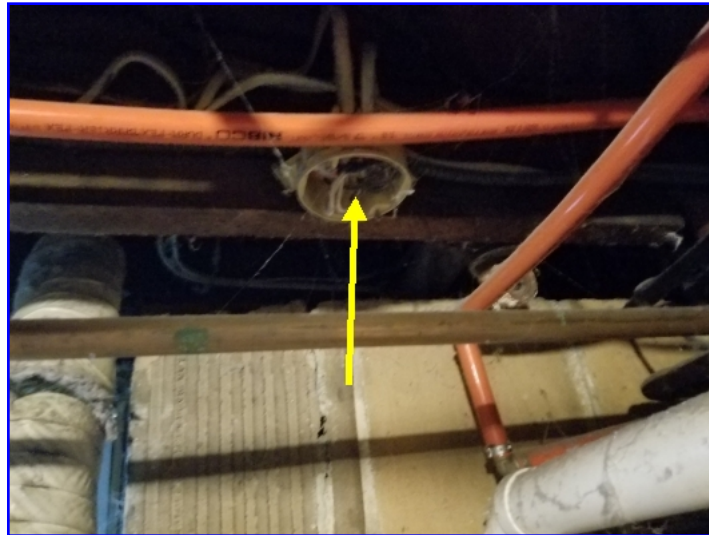
One or more electrical receptacle, switch, light fixture or junction box in the basement was missing a cover plate at the time of the inspection. This condition is a shock/electrocution. Approved cover plates should be installed by a qualified electrical contractor to prevent direct contact with energized electrical components.

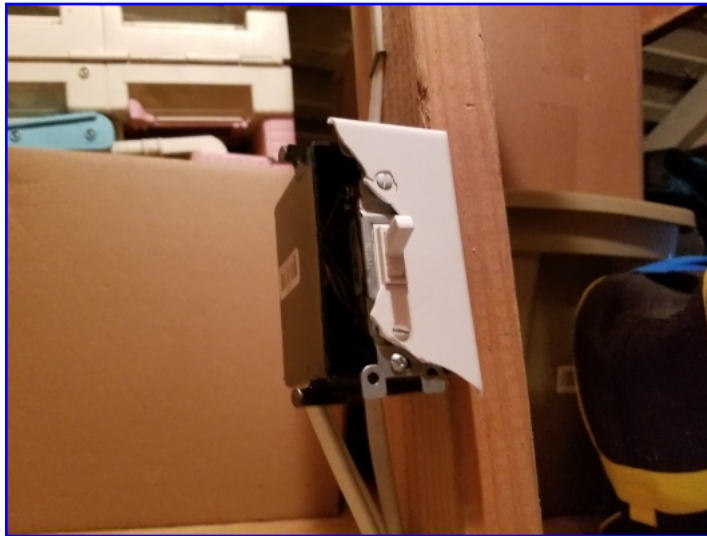
Light switch broken cover.

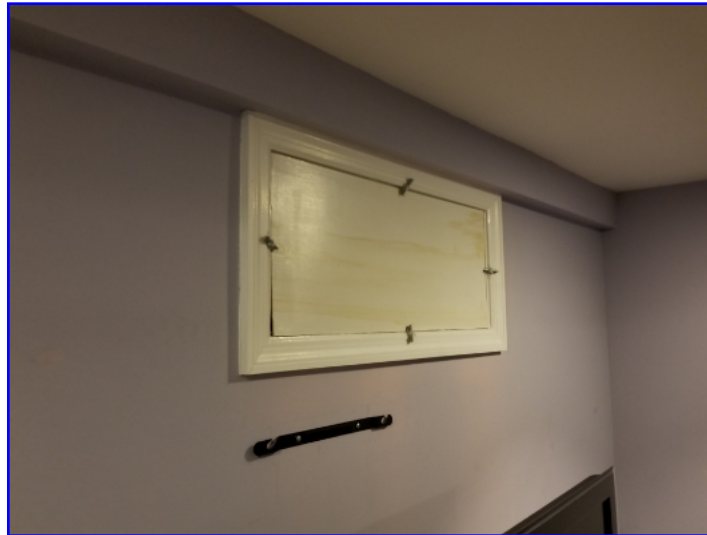
The access hatch opening providing entry to this crawlspace was too small for safe entry. Generally-accepted modern safety standards mandate a crawlspace access size of 18 inches by 30 inches.

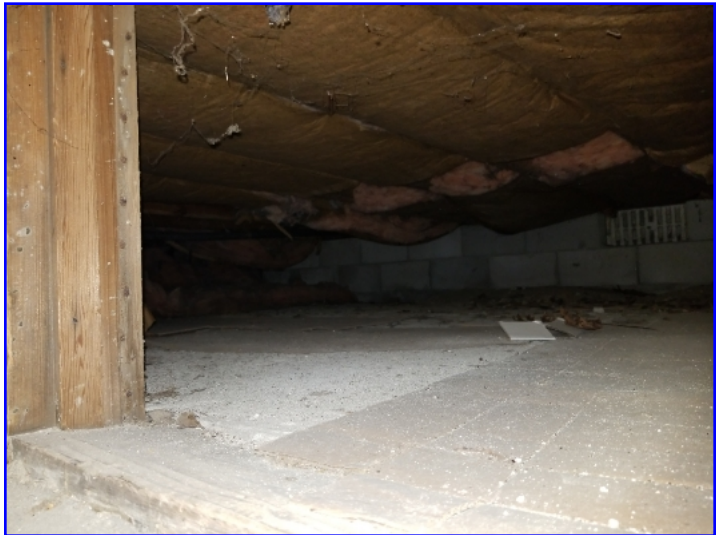
Thermal insulation was installed upside down. Thermal insulation should always be installed with the backing toward the warm side. Installing insulation with the backing toward the cold side can cause problems from excessive condensation.

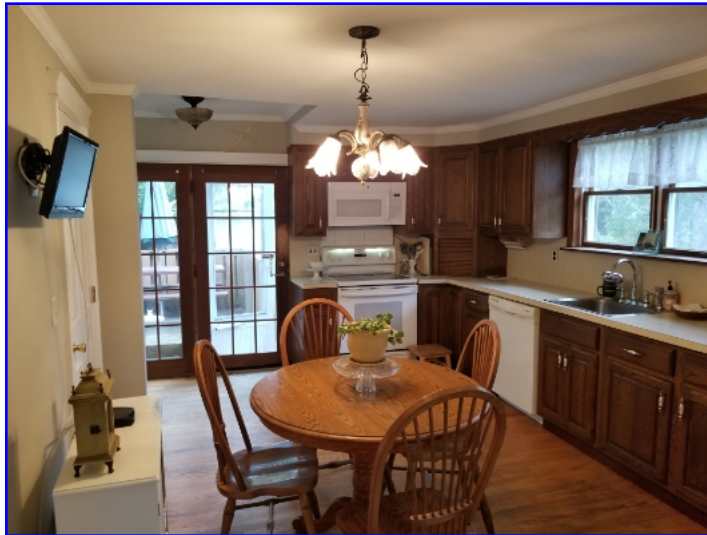
At the time of the inspection, the kitchen exhibited general moderate damage and deterioration commensurate with the age of the home.

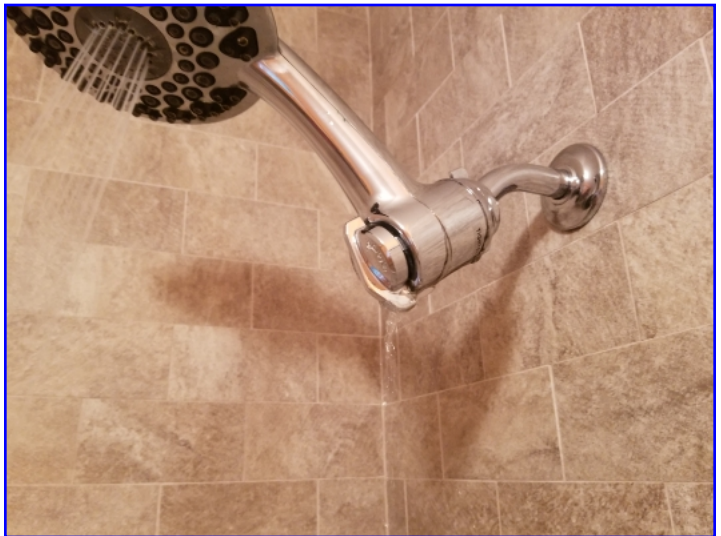
The showerhead connection leaked when the shower was operated. The inspector recommends service by a qualified plumbing contractor.

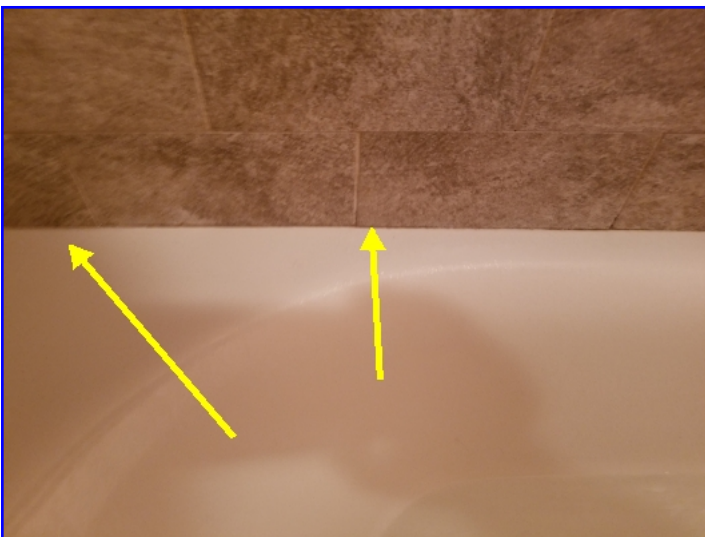
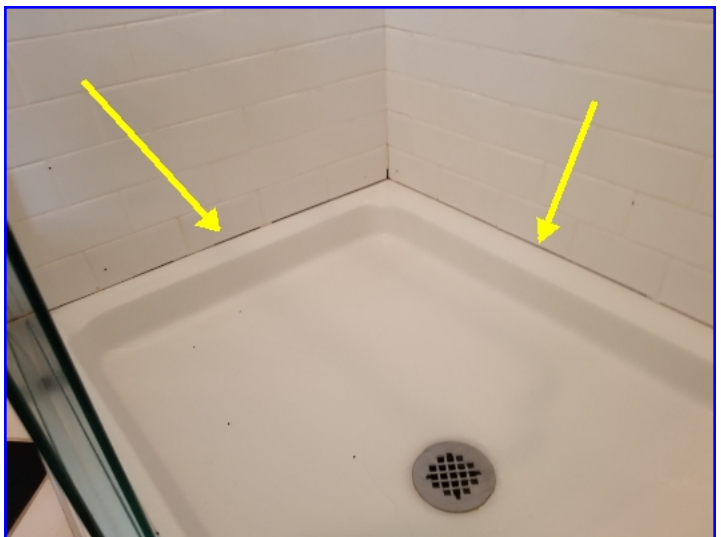
Sealant in the tub where the tile meets the tub was missing and may allow moisture intrusion of the wall/floor structure. The Inspector recommends that sealant be installed by a qualified contractor.

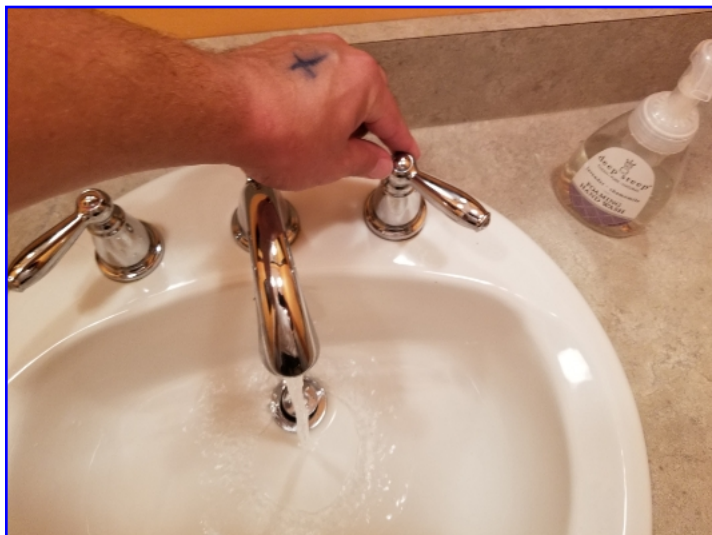
The bathroom sink faucet was loose and should be mounted more securely.

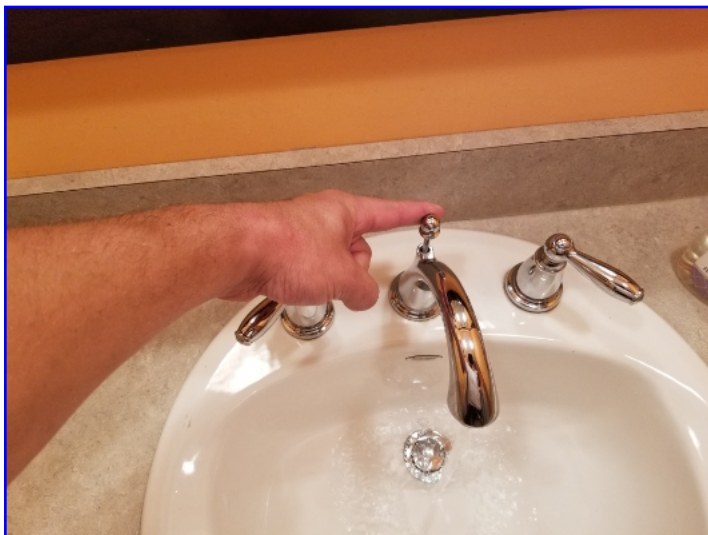
The sink in this bathroom had an inoperable stopper.

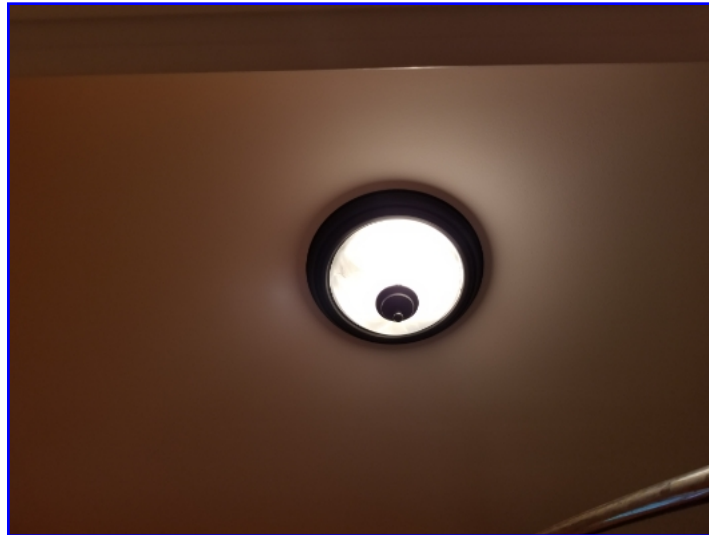
Although both bathrooms had a window, no exhaust fan was installed to exhaust moist air. This condition is likely to result in excessively high humidity levels during the winter when low outside temperatures make ventilation with an open window uncomfortable. Elevated moisture levels may cause a number of problems, such as deterioration of materials and shower wall tile detachment. High humidity can also encourage the growth of microbes such as mold fungi. Excessive growth of mold fungi can produce high concentrations of mold spores in indoor air which can cause serious health problems in some people. Consider installation of an exhaust fan in this bathroom to exhaust moist air to the home exterior. All work should be performed by a qualified contractor.

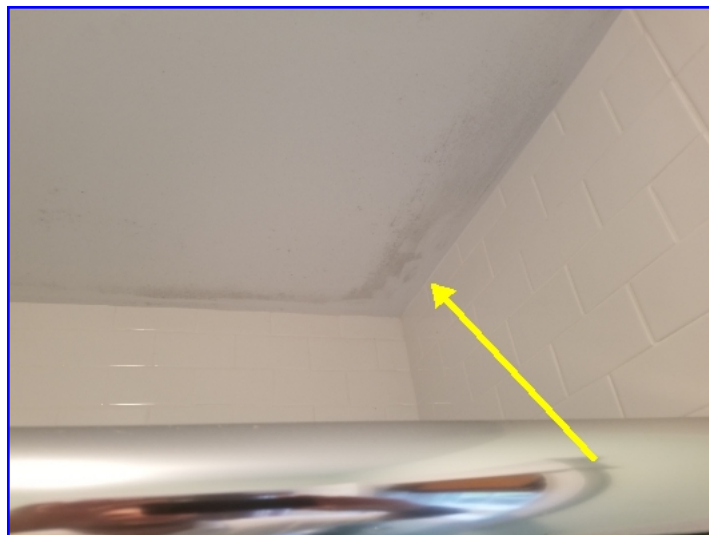
Bathroom downstairs had mold like bacteria on ceiling. This is most likely because there was no ventilation in shower area. The inspector recommends cleaning area and installing bathroom fan.

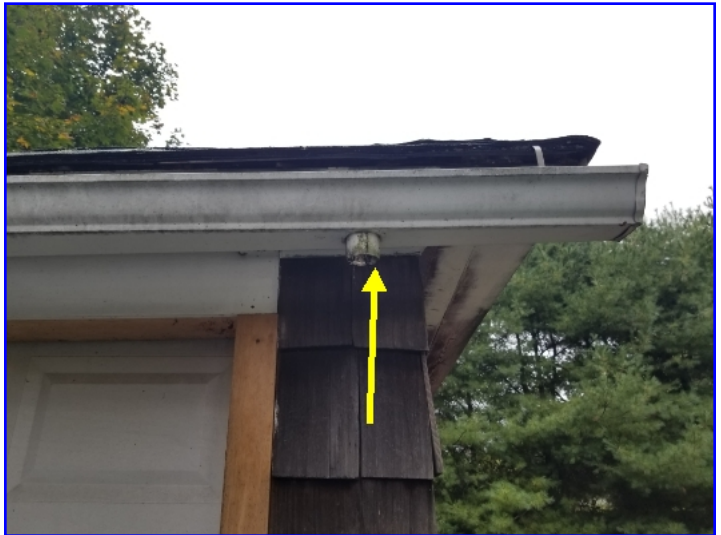
Gutters to garage were disconnected and not functioning. The inspector recommends having licensed contractor replace.

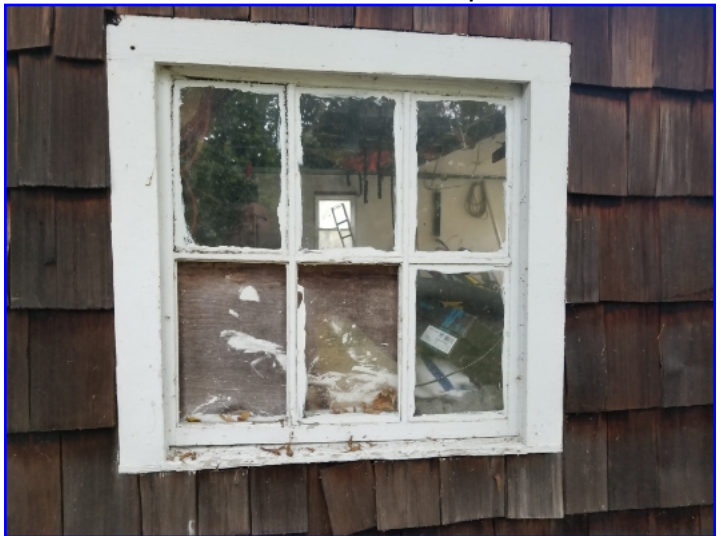
Windows to garage were old and some were broken.

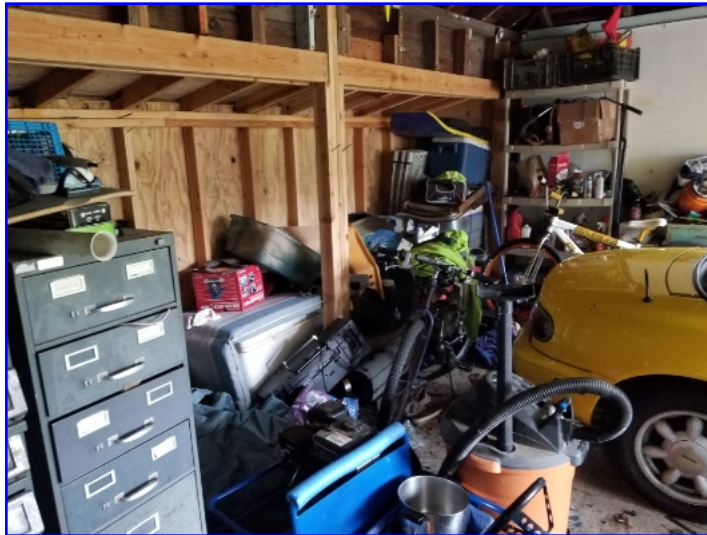
The garage walls had minor damage visible at the time of the inspection.

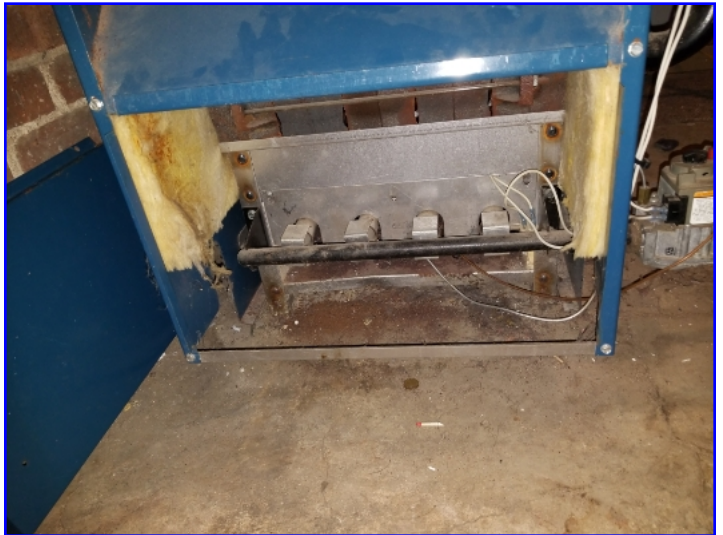
The boiler was dirty. The Inspector recommends having boiler cleaned by a qualified HVAC technician.

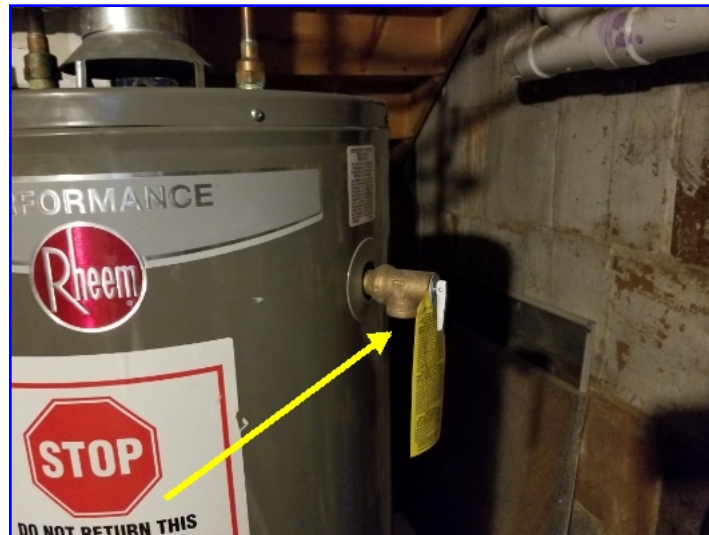
No discharge pipe was installed at the temperature/pressure relief (TPR) valve. The TPR valve is designed to open and release extremely hot water when water temperature or pressure inside the tank exceeds safe levels. With no discharge pipe installed, persons near the tank might be badly burned by hot water released by the TPR valve. The Inspector recommends that a properly-configured discharge pipe be installed by a qualified plumbing contractor.
