PROPERTY INSPECTION REPORT

Your Future address

Date of Inspection: 10/8/2019 Time: 3:15 PM

Age of Home: 1912 Size: 1800sf

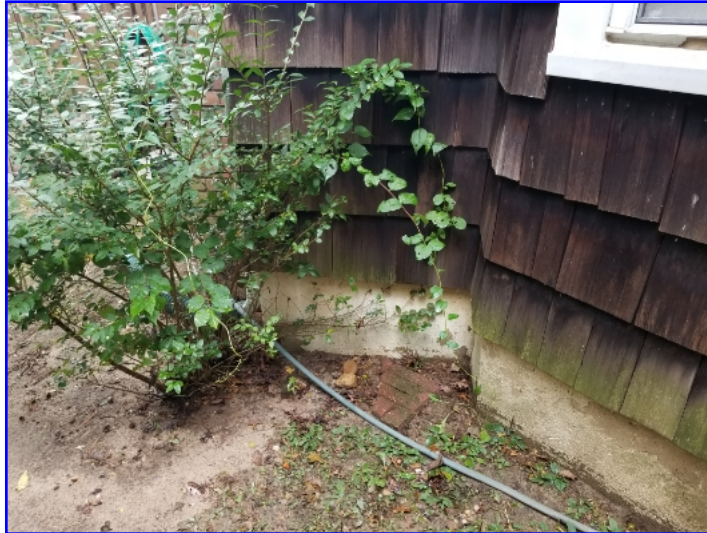
- Shrub and tree growth are not far enough away from the siding of house. Regular maintenance and pruning should be done to prevent contact in the future.

Shrub and tree growth are not far enough away from the siding of house. Regular maintenance and pruning should be done to prevent contact in the future.

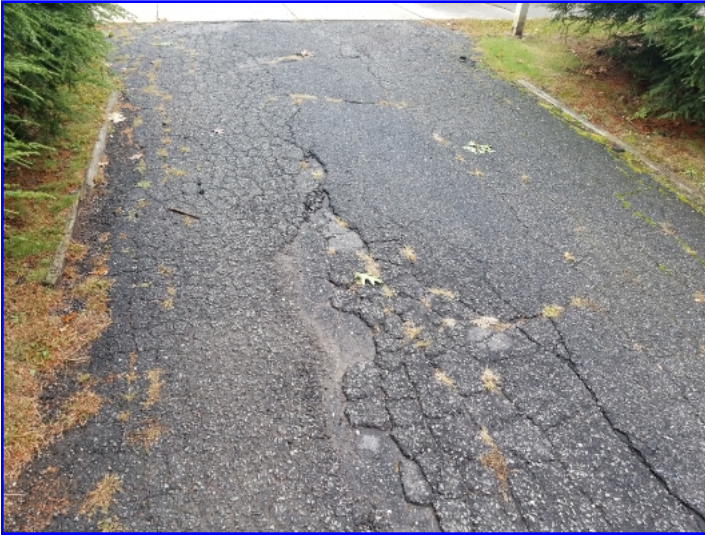
5. Driveway Condition

Page 9 Item: 5	Driveway Condition	<ul style="list-style-type: none">• The driveway was severely deteriorated and needed extensive work at the time of the inspection. The Inspector recommends that before the expiration of your Inspection Objection Deadline you consult with a qualified contractor to discuss options and costs for repair.
----------------	--------------------	--

- The driveway was severely deteriorated and needed extensive work at the time of the inspection. The Inspector recommends that before the expiration of your Inspection Objection Deadline you consult with a qualified contractor to discuss options and costs for repair.

The driveway was severely deteriorated and needed extensive work at the time of the inspection. The Inspector recommends that before the expiration of your Inspection Objection Deadline you consult with a qualified contractor to discuss options and costs for repair.

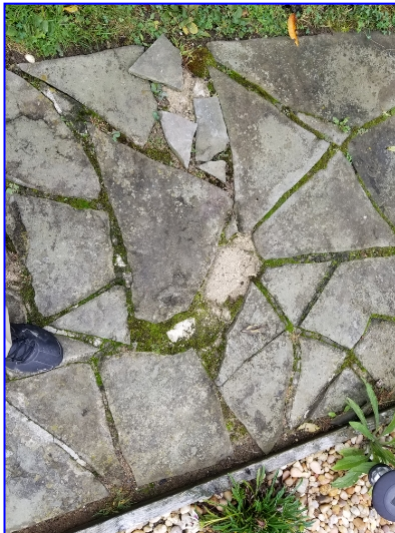
- The stone walkways exhibited moderate deterioration.

The stone walkways exhibited moderate deterioration.

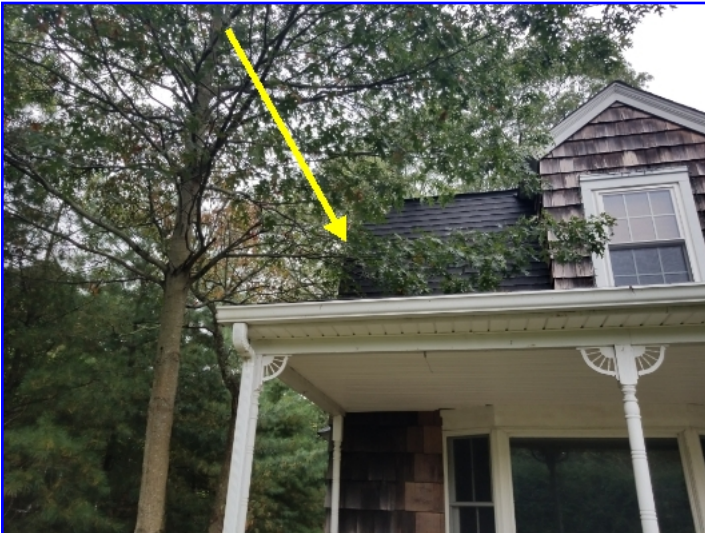
- Large trees near the house have limbs that overhang the home. Falling limbs due to conditions such as wood decay, high winds or heavy snow loads may cause injury, death or damage. Significant weakening of large limbs by conditions such as core decay may not be visible by persons without special training. The Inspector recommends having these trees evaluated by a qualified arborist and that limbs that overhang the roof be cut back. Evaluating trees lies beyond the scope of the general Home Inspection.

Large trees near the house have limbs that overhang the home. Falling limbs due to conditions such as wood decay, high winds or heavy snow loads may cause injury, death or damage. Significant weakening of large limbs by conditions such as core decay may not be visible by persons without special training. The Inspector recommends having these trees evaluated by a qualified arborist and that limbs that overhang the roof be cut back. Evaluating trees lies beyond the scope of the general Home Inspection.

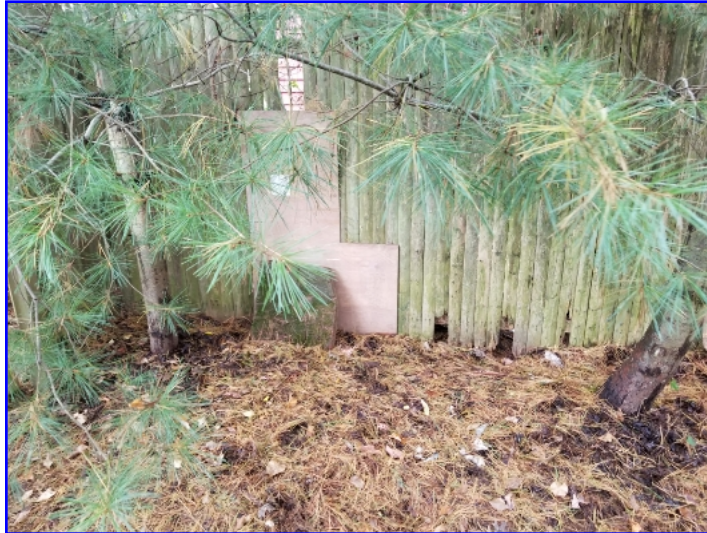
- Fences were made of wood.
- The wood Fence in the back was older. The inspector recommends maintenance be performed.

The wood Fence in the back was older. The inspector recommends maintenance be performed.

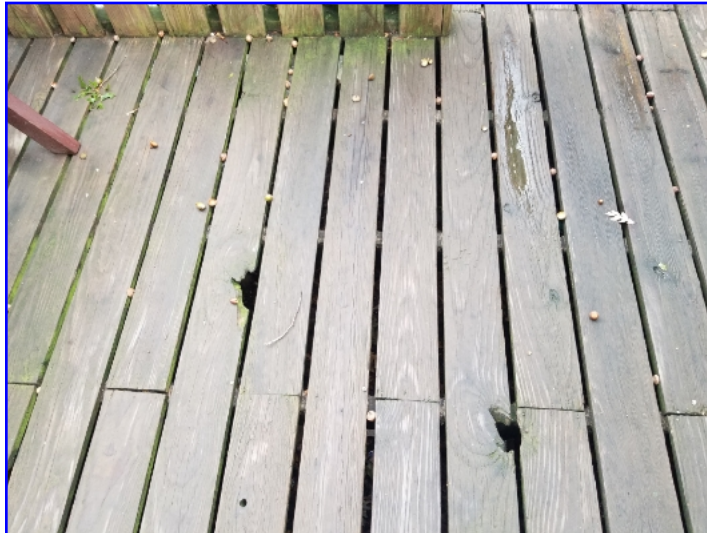
Deck planking (the walking surface) had moderate wear or deterioration visible at the time of the inspection. Routine maintenance will improve its lifespan.

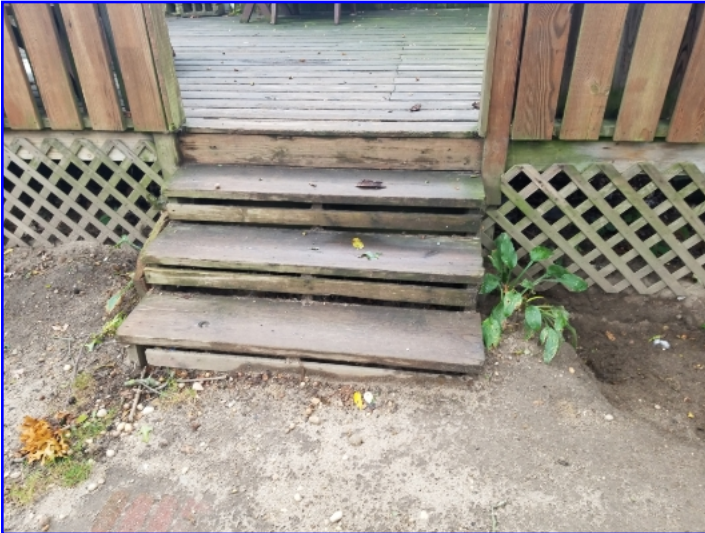
- The deck stair stringers were old, and badly damaged. The Inspector recommends that before the expiration of your Inspection Objection Deadline you consult with a qualified contractor to discuss options and costs for replacement.
- This deck staircase had no handrail. Safe building practices dictate that stairs with 4 or more risers should have a handrail. You should consult with a qualified contractor before the expiration of your Inspection Objection Deadline to discuss options and costs for handrail installation.

The deck stair stringers were old, and badly damaged. The Inspector recommends that before the expiration of your Inspection Objection Deadline you consult with a qualified contractor to discuss options and costs for replacement.

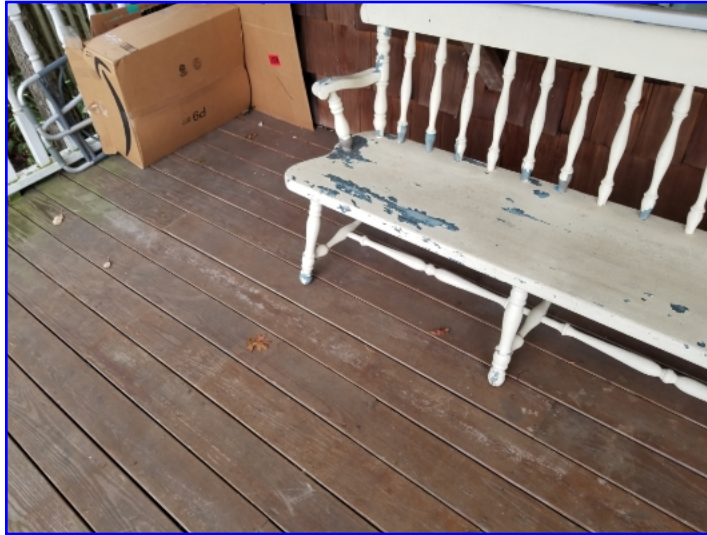
The porch exhibited weathering commensurate with its age.

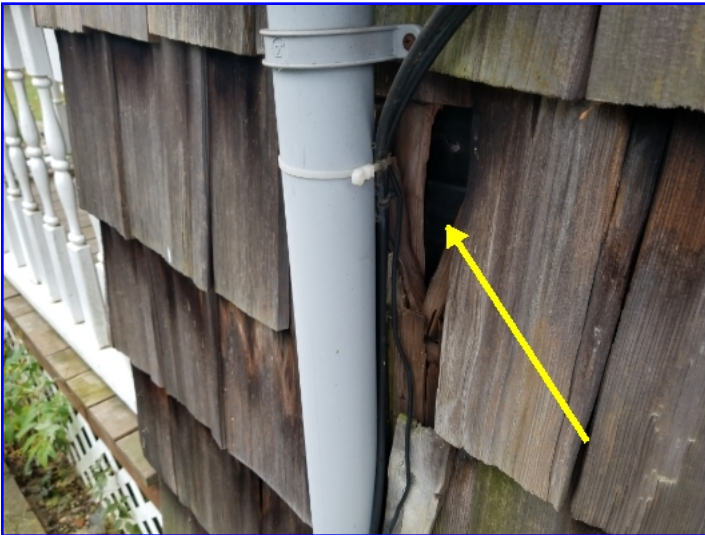
16. Siding defects

- Wood shingles covering exterior walls exhibited moderate deterioration commensurate with the age of the home. Some wood shingles covering exterior walls were split. Splitting is typically due to age and exposure to weather and an often-used rule of thumb calls for replacement when 30% or greater of shingles are split. The percentage of split shingles covering exterior walls appeared to be lower than 30% at the time of the inspection.
- The wood shingle exterior wall covering had some damaged shingles visible at the time of the inspection. The Inspector recommends replacement of damaged shingles to help prevent damage from moisture intrusion to the home materials, the exterior wall structure and to prevent development of microbial growth such as mold. All work should be performed by a qualified contractor. Fill in all holes with appropriate materials.

The wood shingle exterior wall covering had some damaged shingles visible at the time of the inspection. The Inspector recommends replacement of damaged shingles to help prevent damage from moisture intrusion to the home materials, the exterior wall structure and to prevent development of microbial growth such as mold. All work should be performed by a qualified contractor. Fill in all holes with appropriate materials.

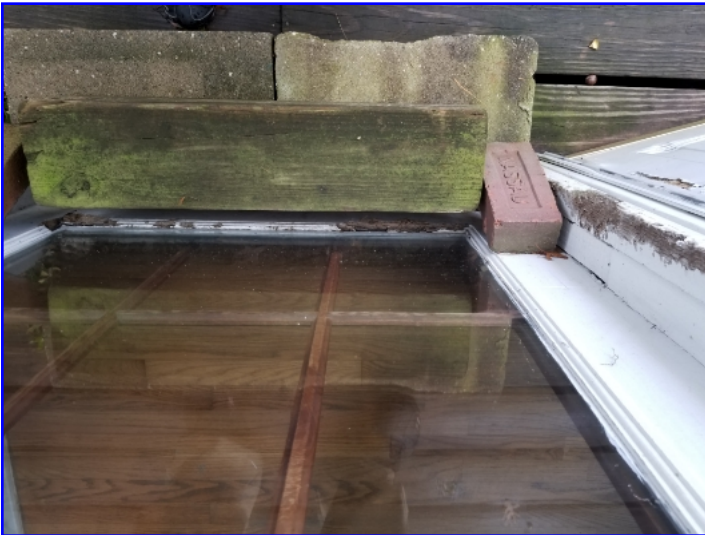
- The exterior doors had light damage or deterioration at the time of the inspection.
- A door to the exterior back deck was severely damaged and/or deteriorated. The Inspector recommends that before the expiration of your Inspection Objection Deadline, you consult with a qualified contractor to discuss options and costs for repair or replacement.

A door to the exterior back deck was severely damaged and/or deteriorated. The Inspector recommends that before the expiration of your Inspection Objection Deadline, you consult with a qualified contractor to discuss options and costs for repair or replacement.

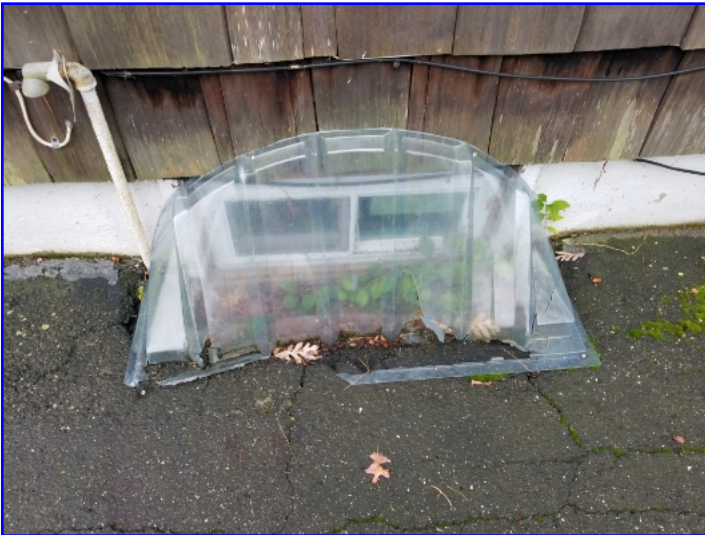
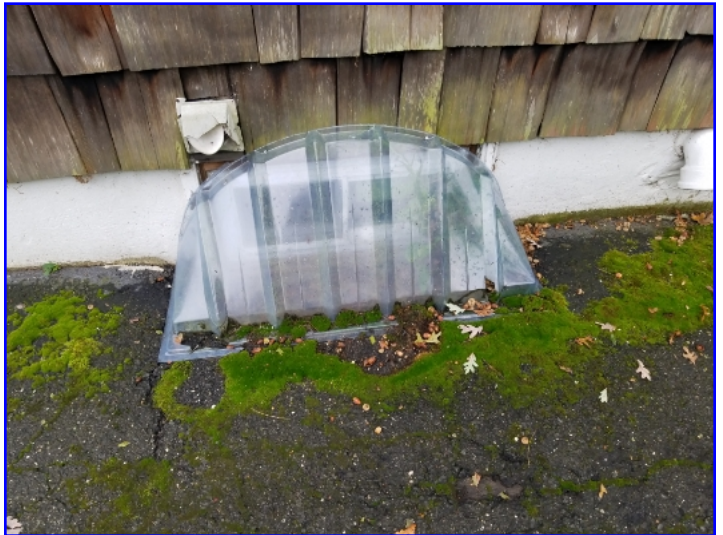
A window well was not securely attached to the home structure.

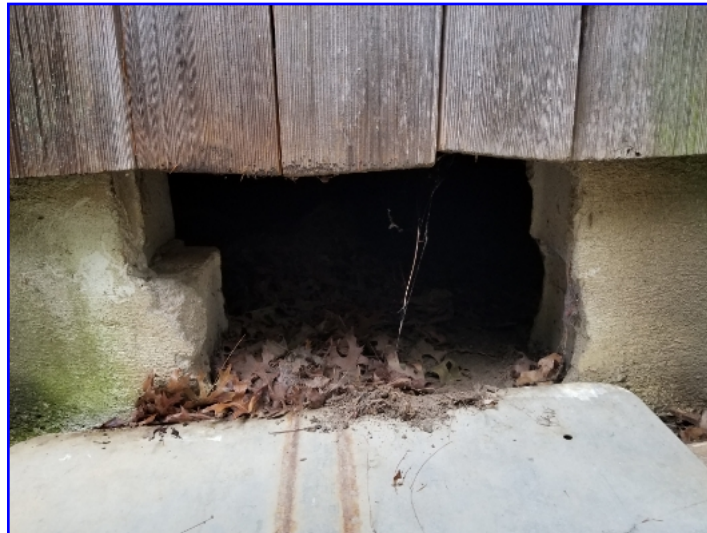
Crawl space window was missing window at time of inspection. The inspector recommends installation by licensed contractor.

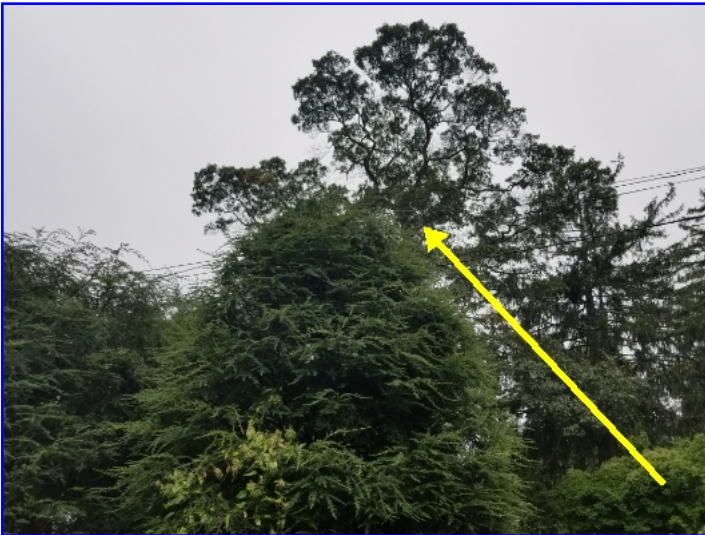
23. Service Drop

Page 19 Item: 23	Service Drop	<ul style="list-style-type: none"> • Service drop conductors were improperly attached. The Inspector recommends correction by a qualified contractor.
Page 20 Item: 25	Exterior Faucets	<ul style="list-style-type: none"> • An exterior faucet at the rear of the house was inoperable. The Inspector recommends repair by a qualified plumbing contractor.

The overhead service-drop conductors were routed near tree branches. Although this did not appear to be a problem at the time of the inspection, as tree branches grow they may begin to contact and abrade the service conductors during windy periods. You should monitor this area in the future and arrange to have tree branches cut back as necessary.

Service drop conductors were improperly attached. The Inspector recommends correction by a qualified contractor.

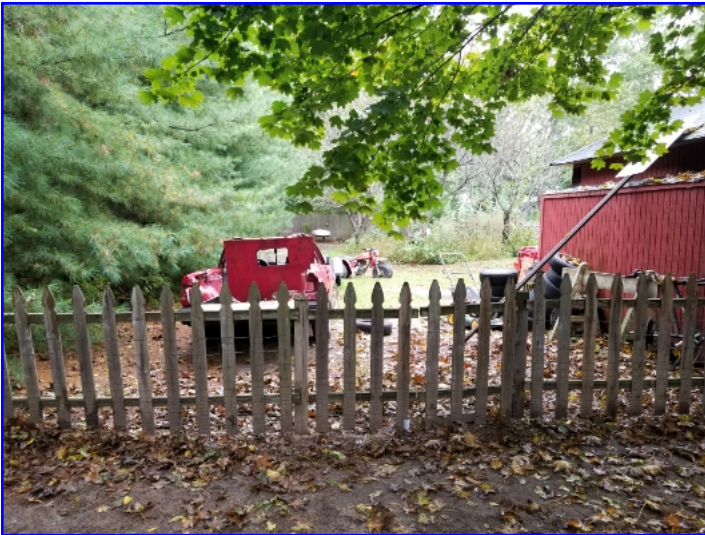
Make sure all debris are removed from property before closing.

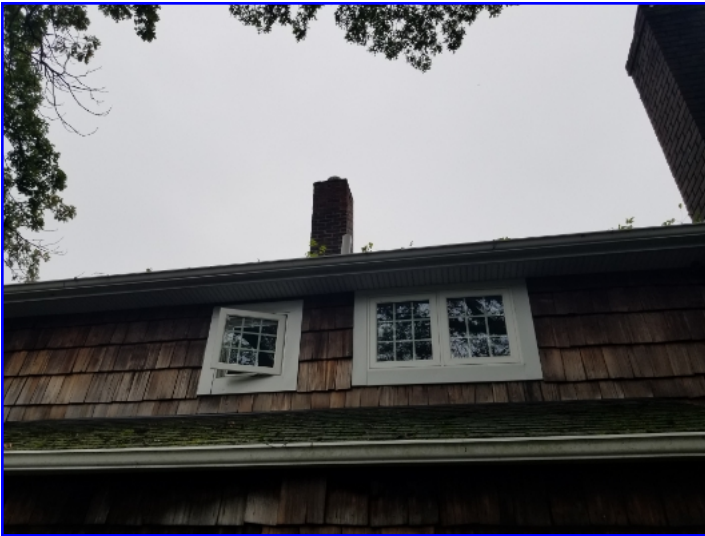
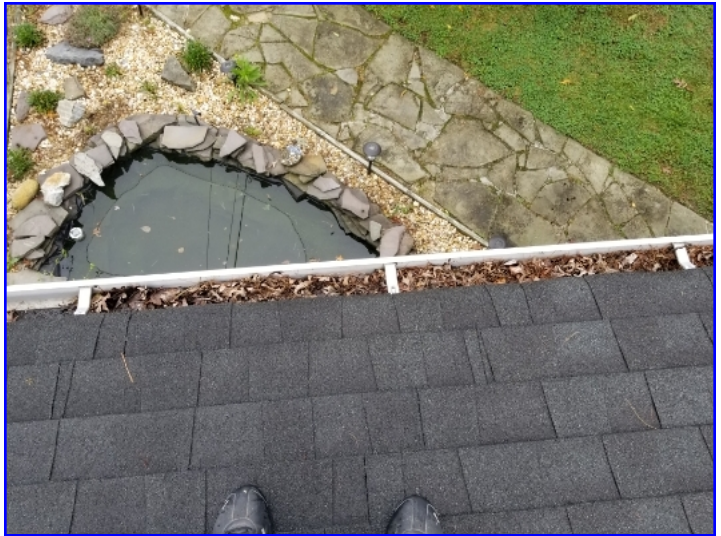
Debris visible in the gutters at the time of the inspection should be removed to encourage proper drainage.

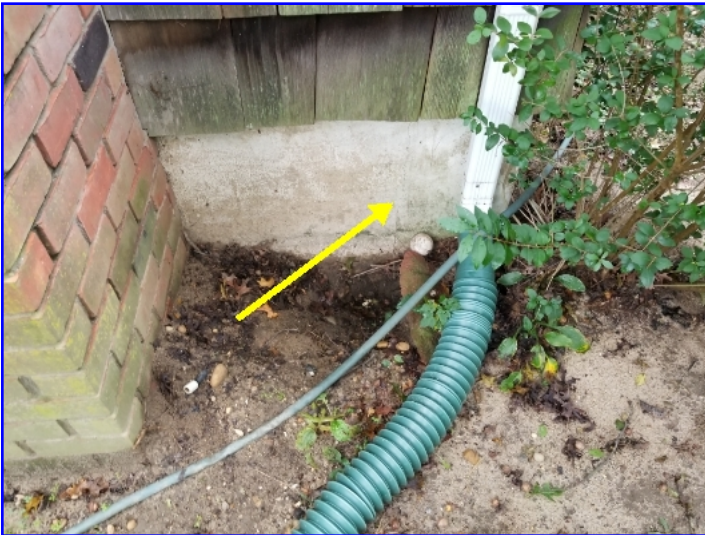
All cracks in exterior block and parge coat should be filled and sealed.

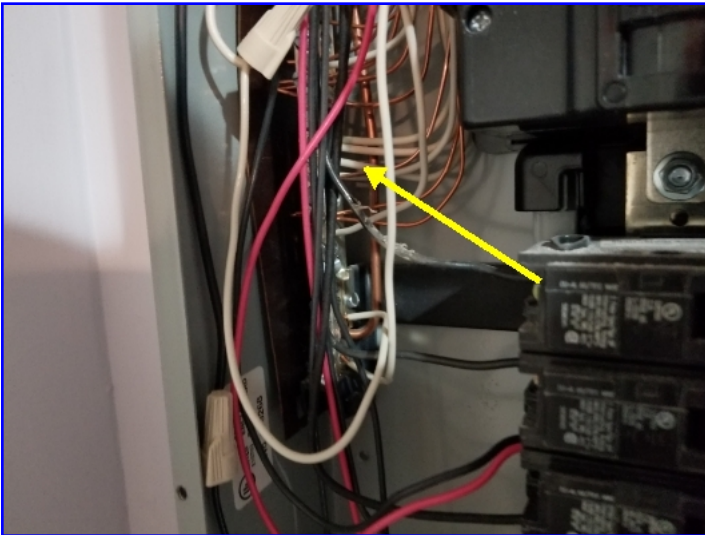
- At the time of the inspection, the Inspector observed no deficiencies in the condition of the service panel. Notable exceptions will be listed in this report.
- Ground and neutral wires in the service panel terminated on the same bus bar. This conditions is improper and should be corrected by a qualified electrical contractor.

Ground and neutral wires in the service panel terminated on the same bus bar. This condition is improper and should be corrected by a qualified electrical contractor.

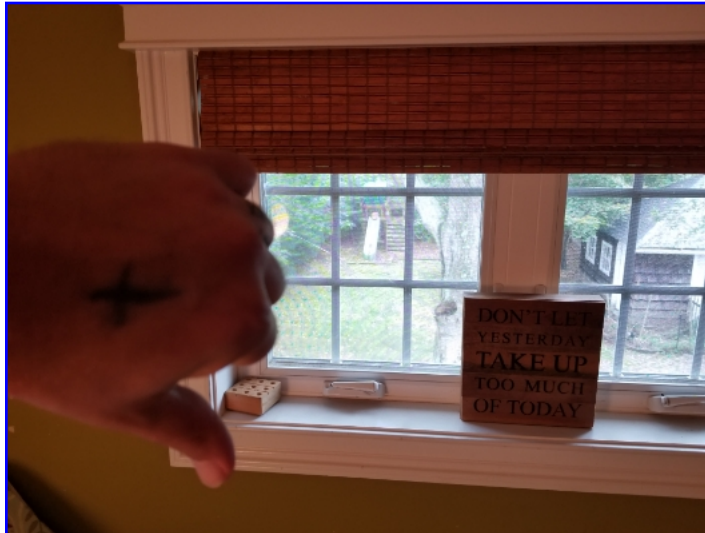
A window at the rear of the home had a cracked or broken pane.

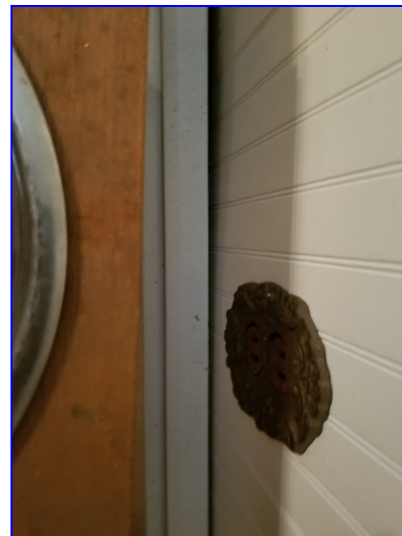
One outlet in living room was two prong. It was not tested.

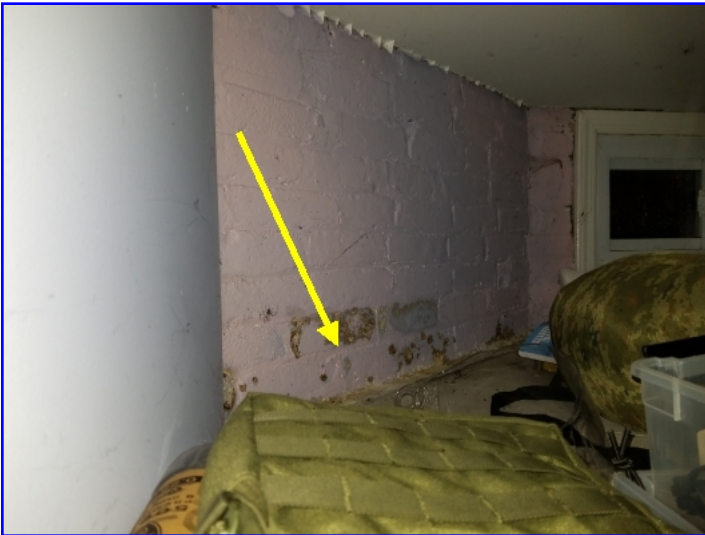
In the basement, moderate amounts of efflorescence was visible at some of the interior surfaces of the foundation walls. Efflorescence is a white, powdery residue left by moisture seeping through the foundation wall and its presence indicates high moisture levels in soil near the foundation. Excessively high moisture levels in soil supporting the foundation can cause various structural problems related to soil movement. The source of moisture should be identified and the condition corrected.

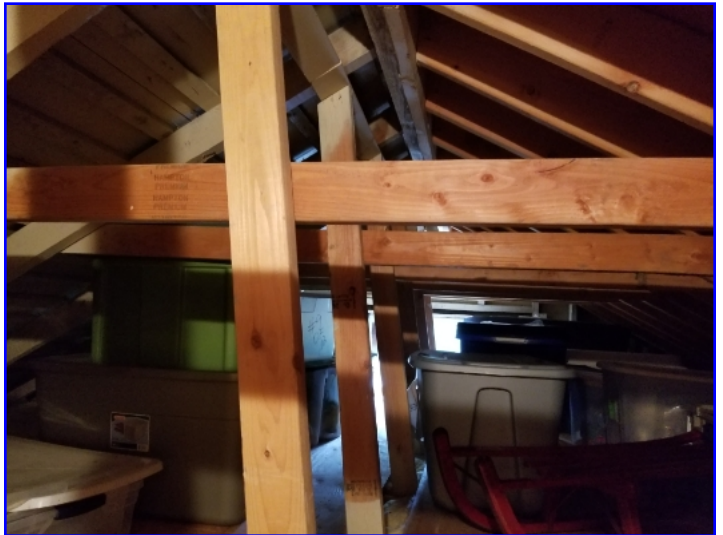
The attic was accessed by a ceiling-installed pull-down ladder in the hallway.

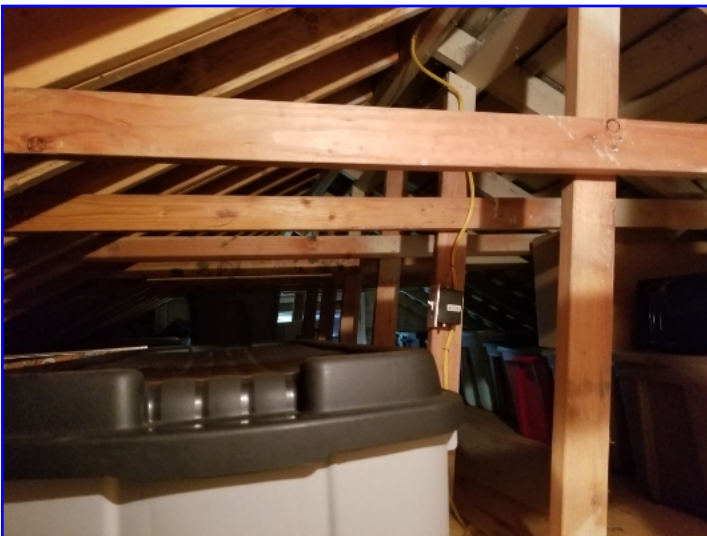
Some areas of the attic were not visible due to the occupant's belongings. The Inspector recommends inspection of these portions of the basement by a qualified inspector after access has been provided.

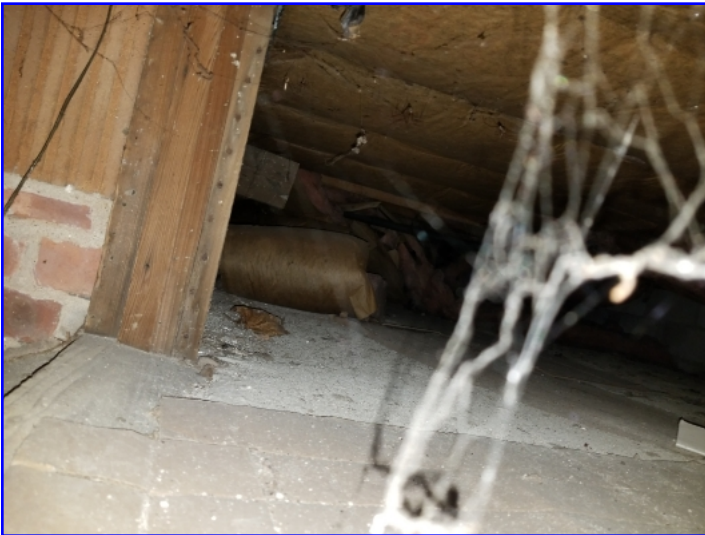
Thermal insulation was installed upside down. Thermal insulation should always be installed with the backing toward the warm side. Installing insulation with the backing toward the cold side can cause problems from excessive condensation.

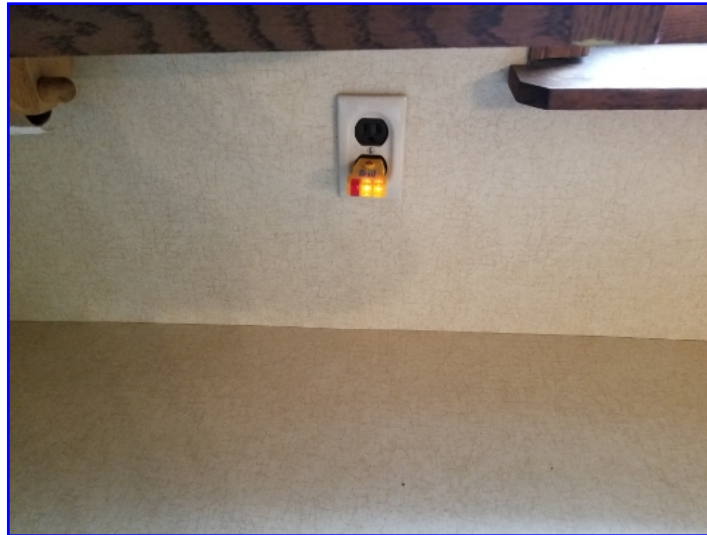
At the time of the inspection, the Inspector observed few deficiencies in the condition of electrical outlets in the kitchen. Notable exceptions will be listed in this report. Outlets had no Ground Fault Circuit Interrupter (GFCI) protection. For safety reasons, consider having GFCI protection installed for outlets within 6 feet of a plumbing fixture.

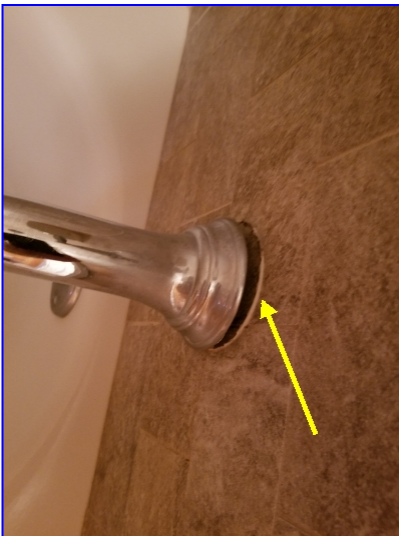
In this bathroom, the diverter valve was loose and not caulked. (the diverter is the valve which diverts water from the tub faucet to the shower head). The inspector recommends service by a qualified plumbing contractor.

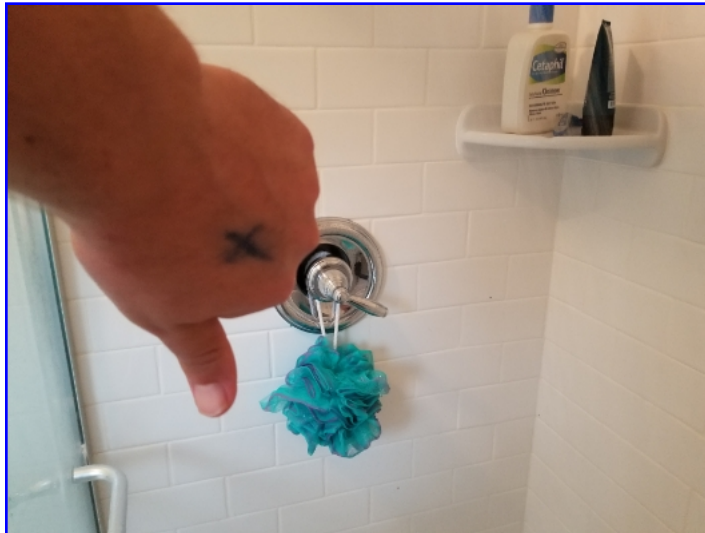
Hot and cold water connections were reversed at the shower in this bathroom. The inspector recommends correction by a qualified plumbing contractor.

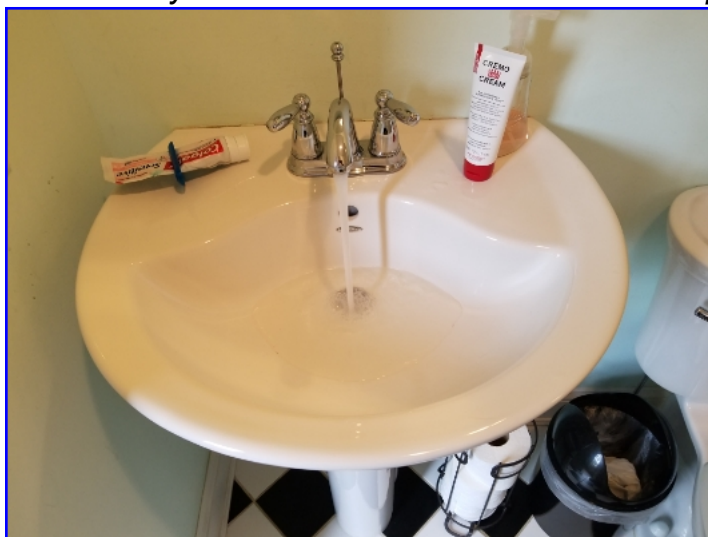
Bathroom downstairs sink ok.

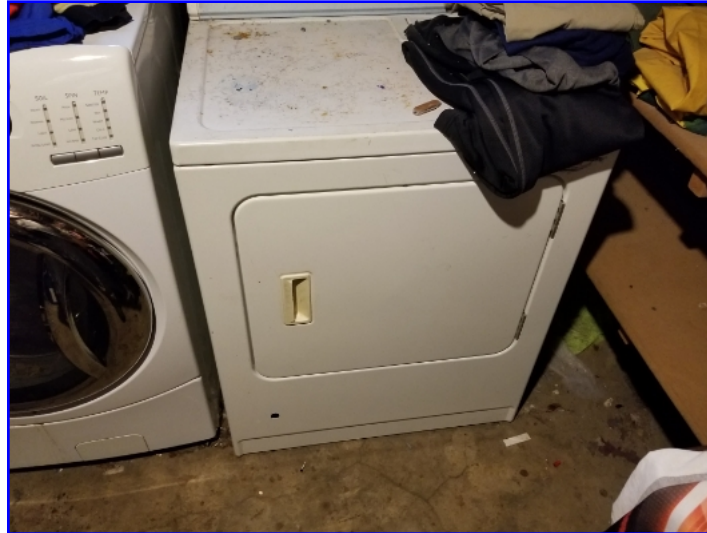
- The dryer was older and fueled by gas. It was functional at time of inspection. The inspector recommends checking at final walk through.

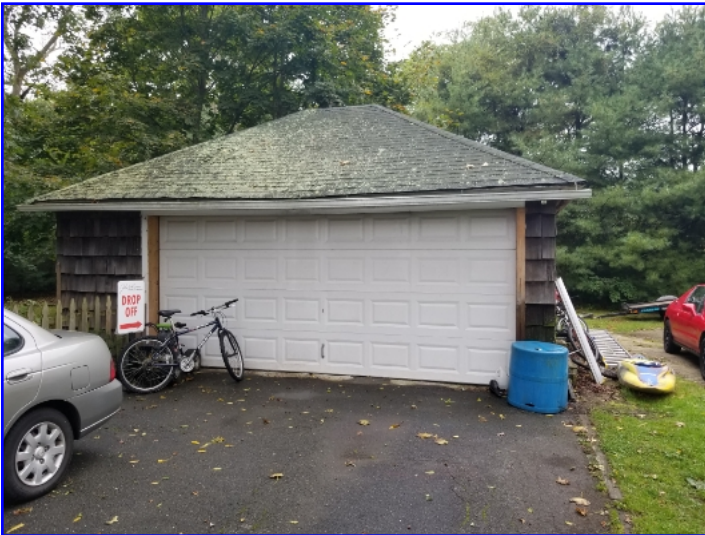
The home had a 2-car detached garage.

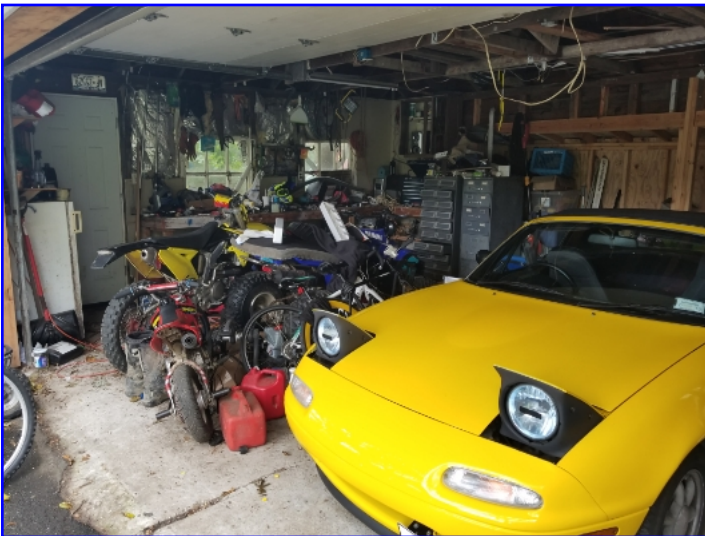
Due to the large amounts of stored items and cluttered conditions, some areas of the garage were not readily accessible for inspection. Do a careful check of any previously obstructed areas during your final walkthrough.

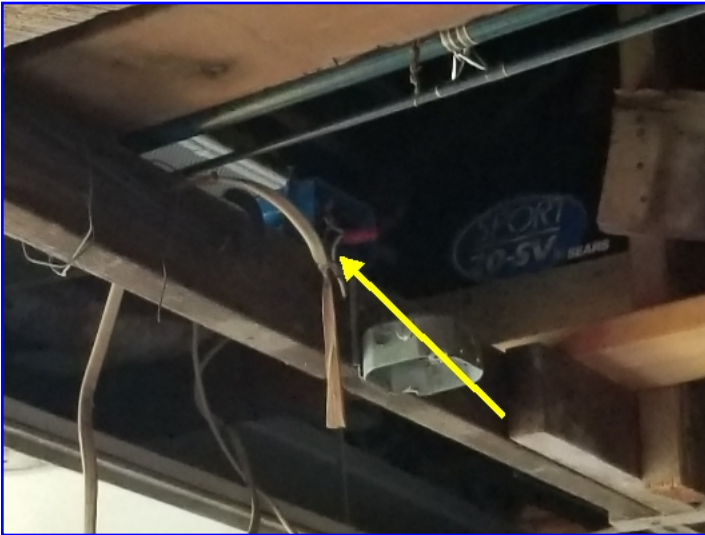
Exposed wire splices visible in garage are a shock/electrocution hazard and should be enclosed within an approved junction box with a listed cover by a qualified electrical contractor.

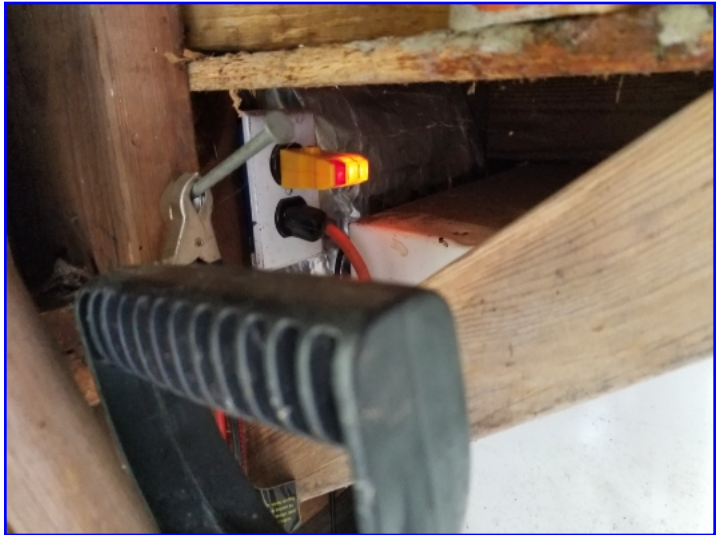
Outlets in garage were working at time of inspection.

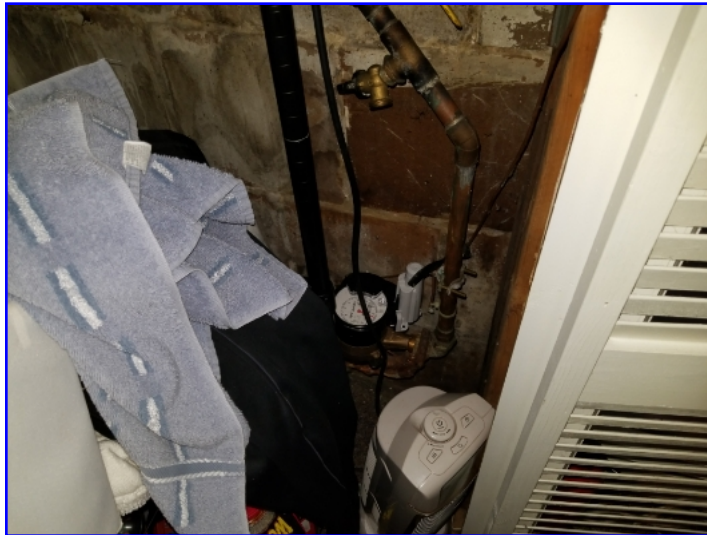
The Water Main was located in the Basement.

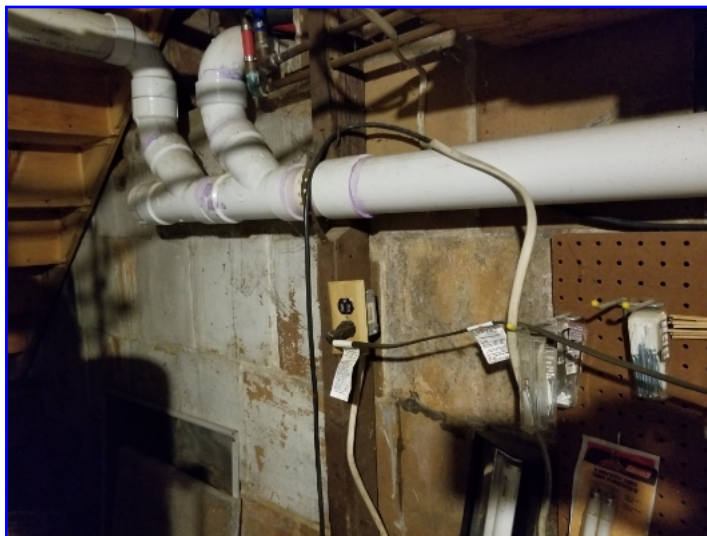
The visible drain, waste and vent (DWV) pipes were a combination of cast iron and approved PVC.

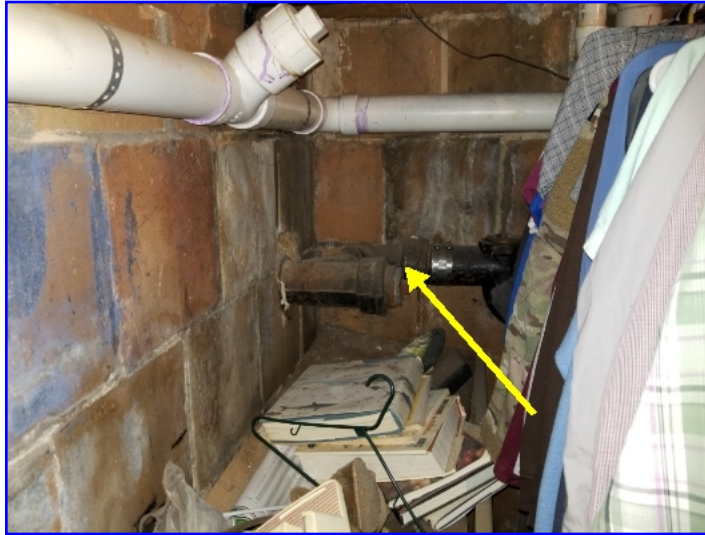
Main clean outs located in basement.

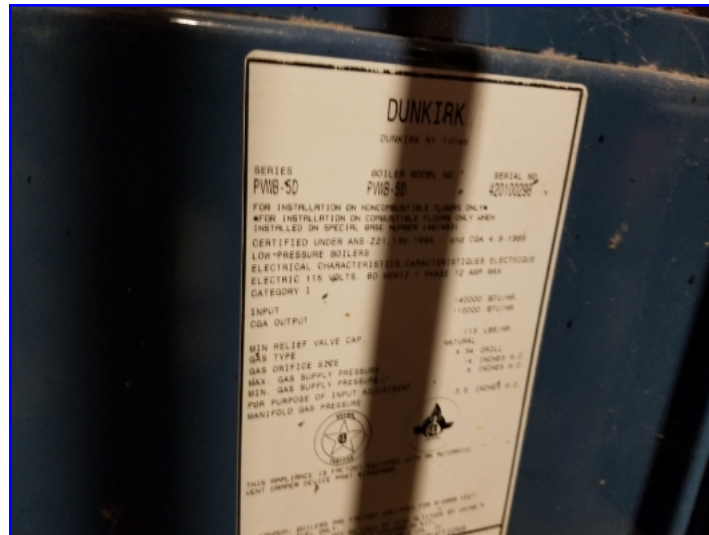
- The boiler date of manufacture was 2001
- The boiler brand was Dunkirk.

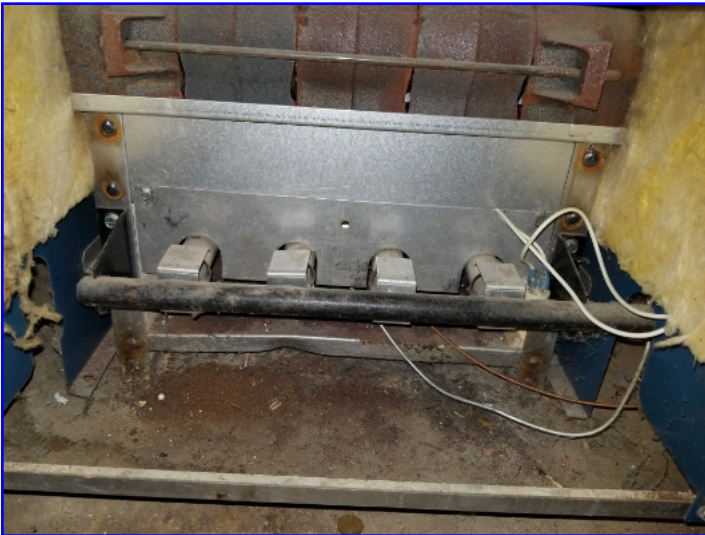
The boiler responded to the demand for heat.

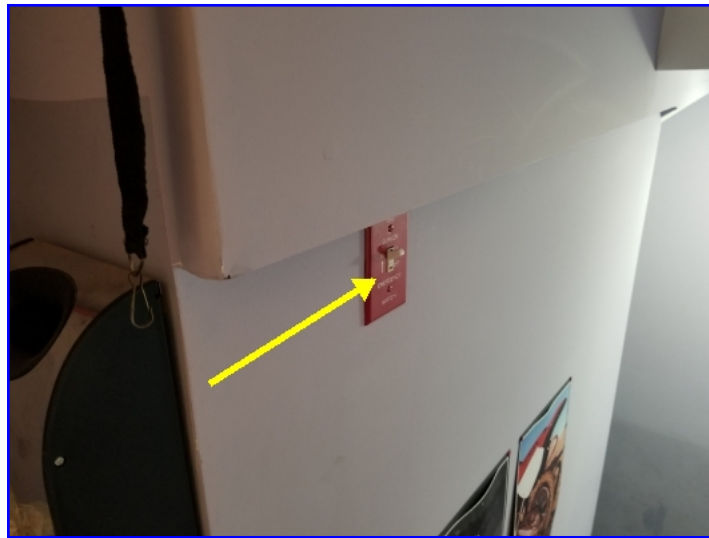
The photo shows the electrical shut-off for the boiler.

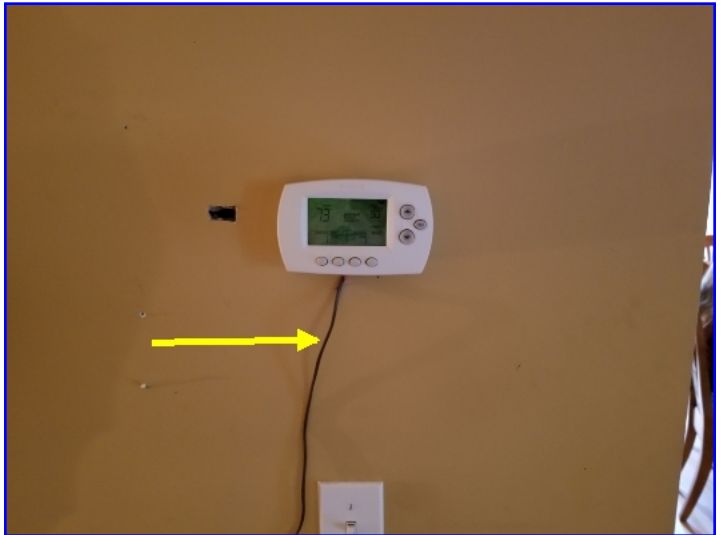
- The boiler had two thermostats. Two ones of heating.
- Thermostat wires to downstairs were not installed correctly and should be installed by licensed hvac contractor.

Thermostat wires to downstairs were not installed correctly and should be installed by licensed hvac contractor.

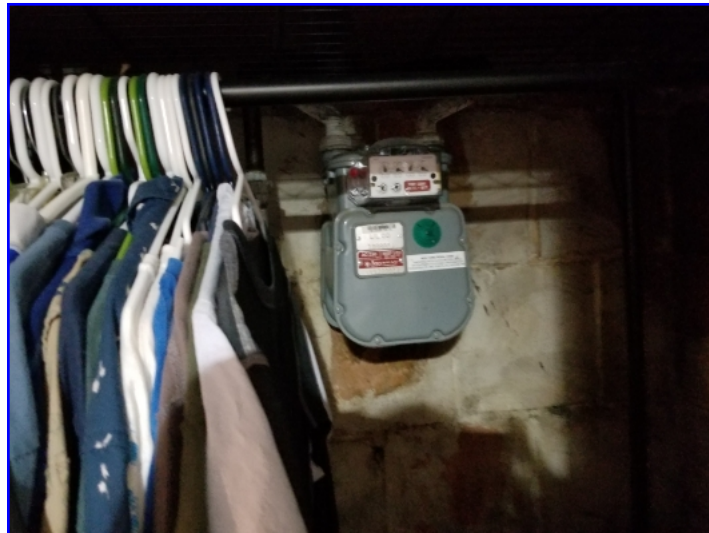
The home was fueled by natural gas supplied by a public utility.

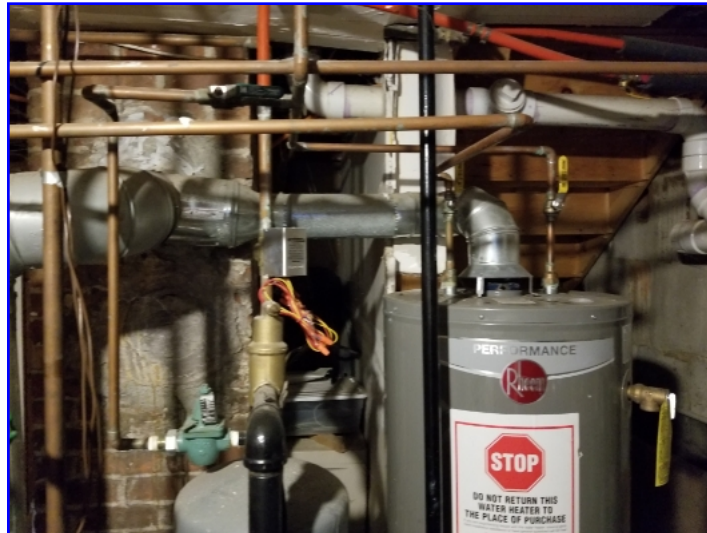
The water heater was manufactured by Rheem.

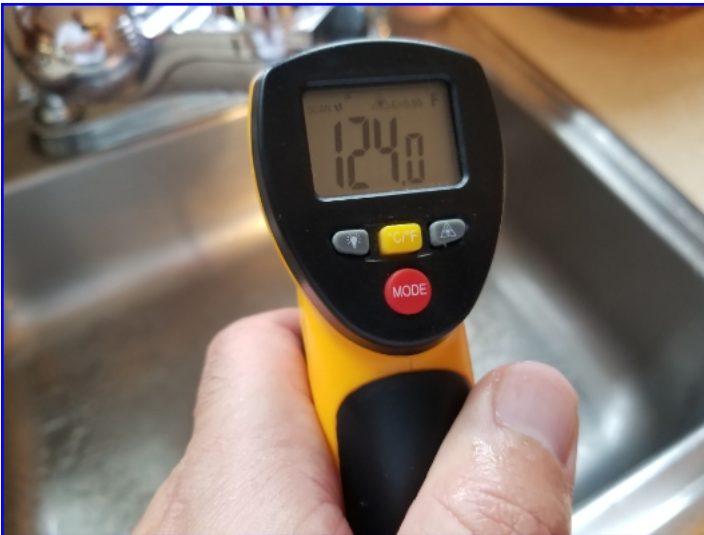
- At the time of the inspection, the Inspector observed few deficiencies in the condition of the water heater. Notable exceptions will be listed in this report.
- Water to most faucets and showers was over 125 degrees. This can burn quickly. Recommend turning water heater down.

Water to most faucets and showers was over 125 degrees. This can burn quickly. Recommend turning water heater down.

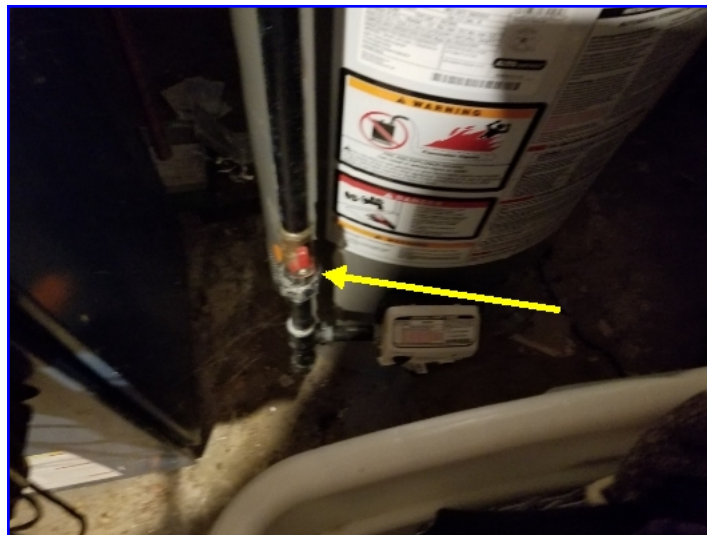
The photo shows the location of the shut-off valve for gas at the water heater.
